Service Report

CUSTOMER: NOAA	VESSEL/FACTORY/SITE: Okeanos Explorer	DATE: 05/17/2013
LOCATION: Charleston, SC	ENGINEER: Tony Dahlheim	SERIAL/FILE No:
WORKORDER / PO: W131924-LBR	ACCOUNT/PROJECT No:	CONTRACT No:

Impedance check on 1728 elements on EM302 TX array. Replace HWS10 with new HWS N5, install SIS and configure N5. Also perform EM302 calibration. Perform EK60 18kHz calibration.

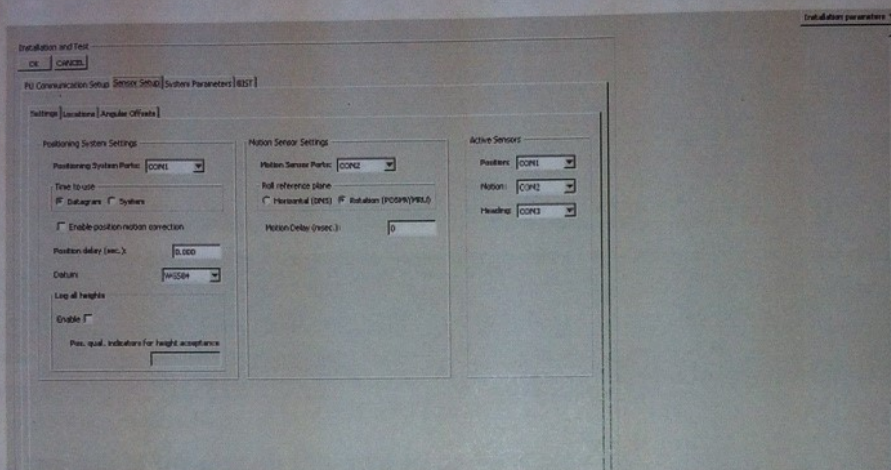
(Figure 2)

Found bad pings in geo display on SIS stating zero in depths on screen this seems not to affect the raw data being collected by the EM302 system. Will contact Norway main office about this issue in the geo display. See figure 1 below.

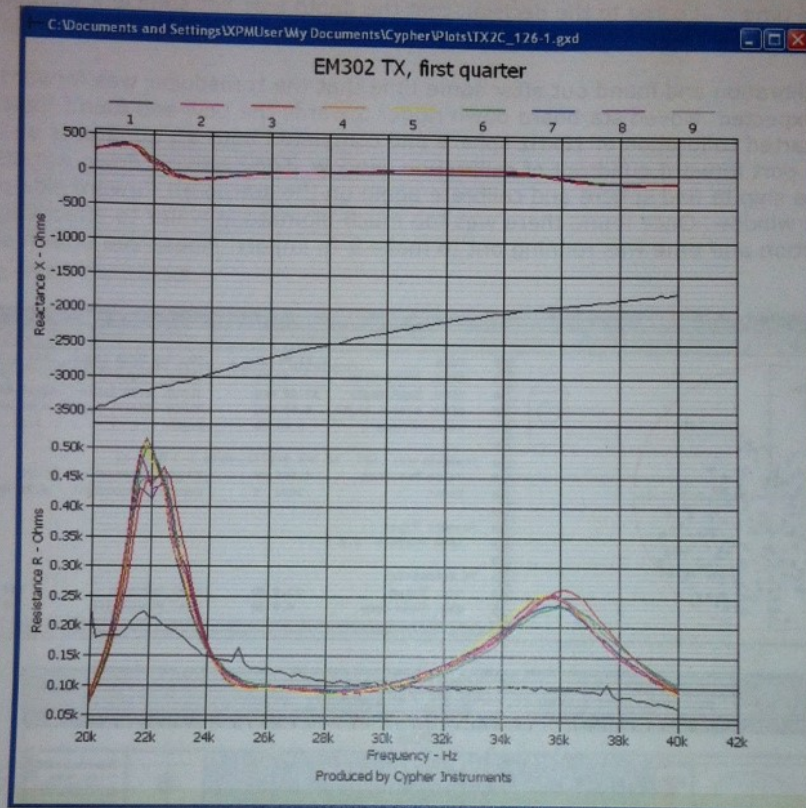
Slot 6	Slot 8	Slot 12	Slot 13	Slot 16
Ch:21 High Z	Ch:6 Open	Ch:2 High Z	Ch:0 High Z	Ch:18 Low voltage
	Ch:9 Open	Ch:33 High Z	Ch:1 High Z	
		Ch:34 High Z	Ch:2 High Z	
		Ch:35 High Z

Due to the age of the system this appears to be normal. EM302 system can lose about 10% of the TX channels and still be operational. This is currently only 11 channels out of 1728 channels. NOAA personnel will be responsible for monitoring the TX array over time to check if more TX channels show results like these ones shown above.

Went over Cypher testing results and so far the results match up with the extended BIST TX channels tests. Please see below for an example of TX2C_126-1 cable, slot 6, ch:21, High Z, element 397.

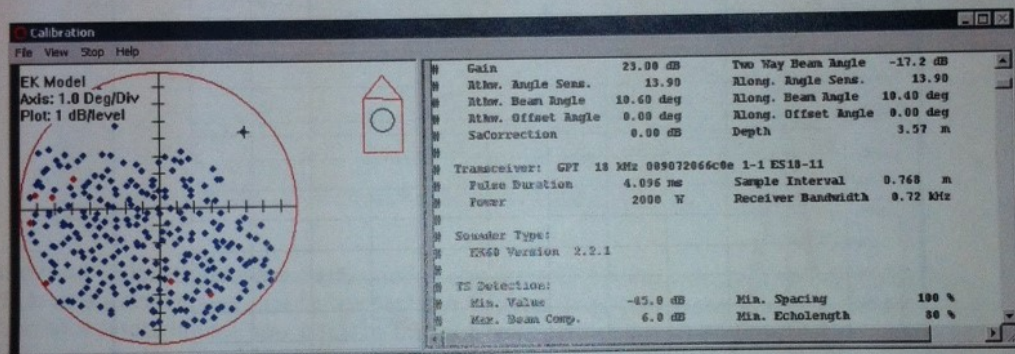
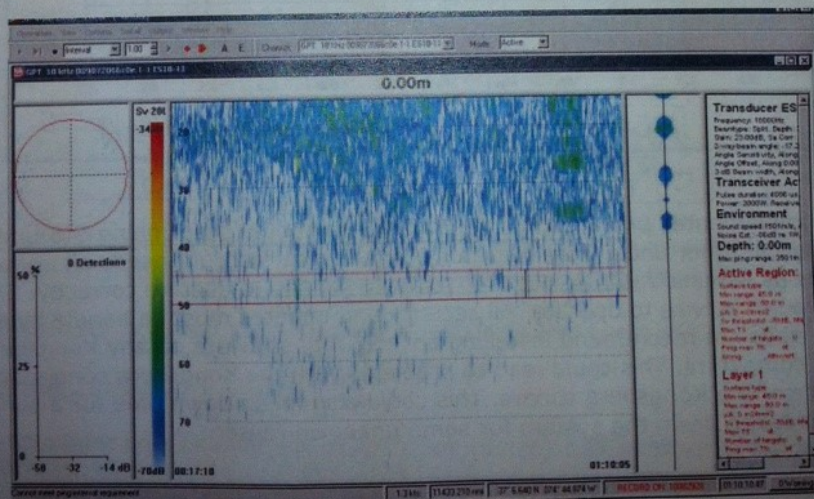
Started calibration and found out after some time that the transducer was forward of what we expected. Moved starboard down rigger towards the bow and found the 18 kHz sphere. Started calibration of 18kHz sphere and completed both aft quadrants and about half of the port forward quadrant of calibration window. Tried moving down riggers and moving the ship to find sphere and calibrate again on the starboard forward side of calibration window. Once found there was too much biomass in water to effectively do the calibration and time was running out to make it to import. Please see screen shots below.

Unsuccessful calibration of EK60 18kHz system.
