# ROV Dive Summary

## EX2503, Dive 06, April 19, 2025

Site Name	USS Yorktown Dive #1
General Area Descriptor	Papahānaumokuākea
Science Team Leads	Sara Kahanamoku-Meyer (UH Mānoa/HI Sea Grant) and Brian Kennedy (ODL/BU)
Expedition Coordinator	Sam Cuellar (NOAA Ocean Exploration)
ROV Dive Supervisor	Chris Ritter (GFOE)
Mapping Lead	Neah Baechler (NOAA Ocean Exploration/UCAR)
Sample Data Manager	Anna Lienesch and Jordan Schweizer (NCEI)

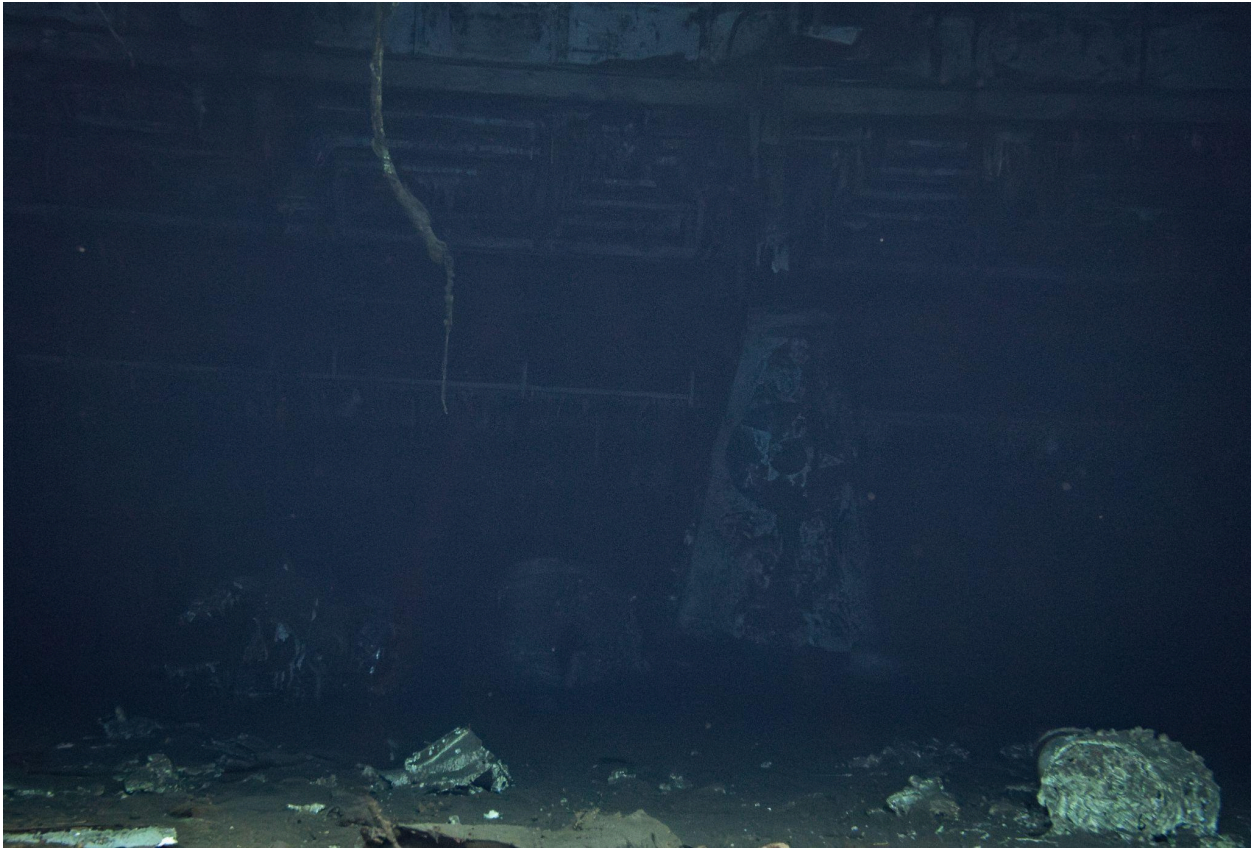
Looking forward from the elevator, an aircraft wing was observed on its side on the hangar deck, with a likely star and dot insignia on the wing barely visible. Other debris and sediment layer the floor of the hangar deck.

A plane wing is seen propped up against the starboard wall of the hangar deck on *USS Yorktown*.

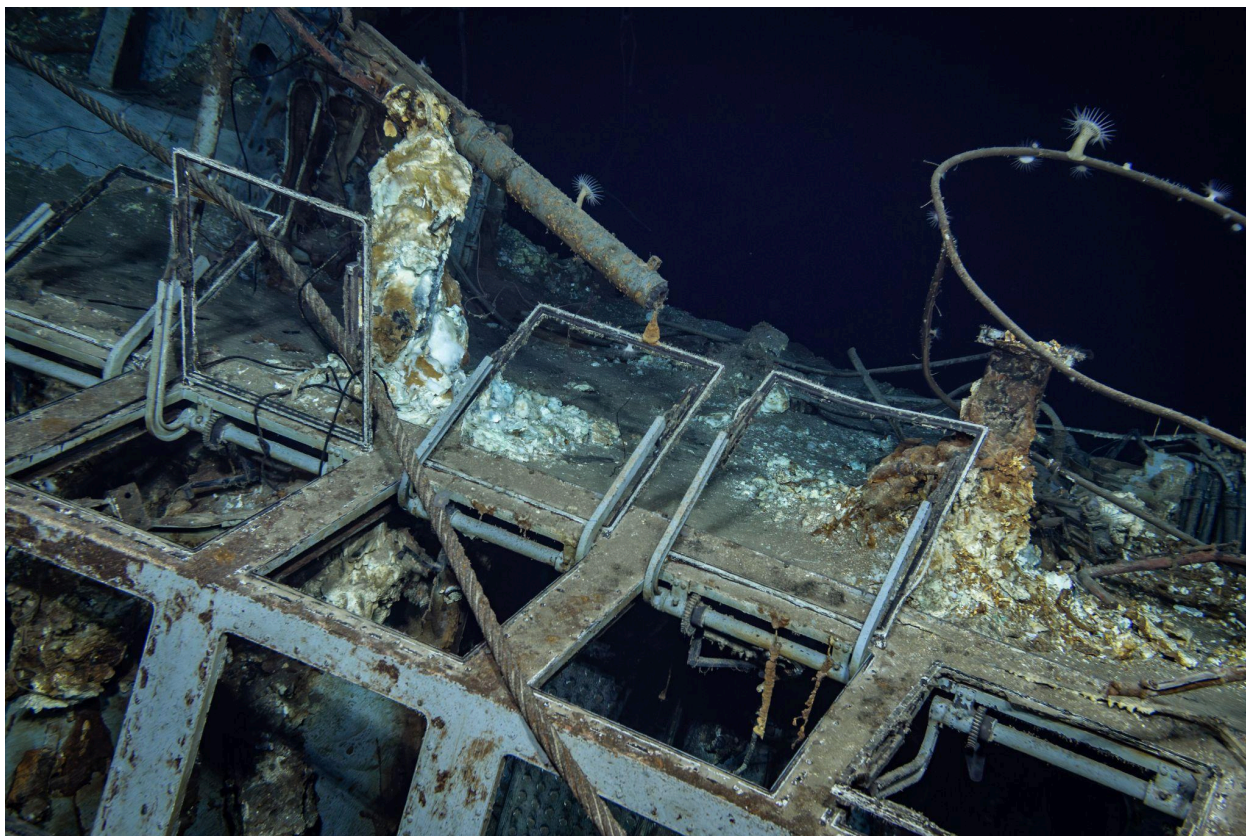
D2 moved forward along the port side of the island, passing the windows and skylights of the Pilot House and Navigating Bridge. Damage to the island and bridge superstructure can be seen. A large cable (possibly a tow cable) is draped across the Navigating Bridge, and one of the 50 cal gun emplacements and MK33 gun directors was imaged.

A presumed tow cable from *Yorktown's* salvage efforts drape across the bridge, just in front of a mounted .50 caliber gun position.

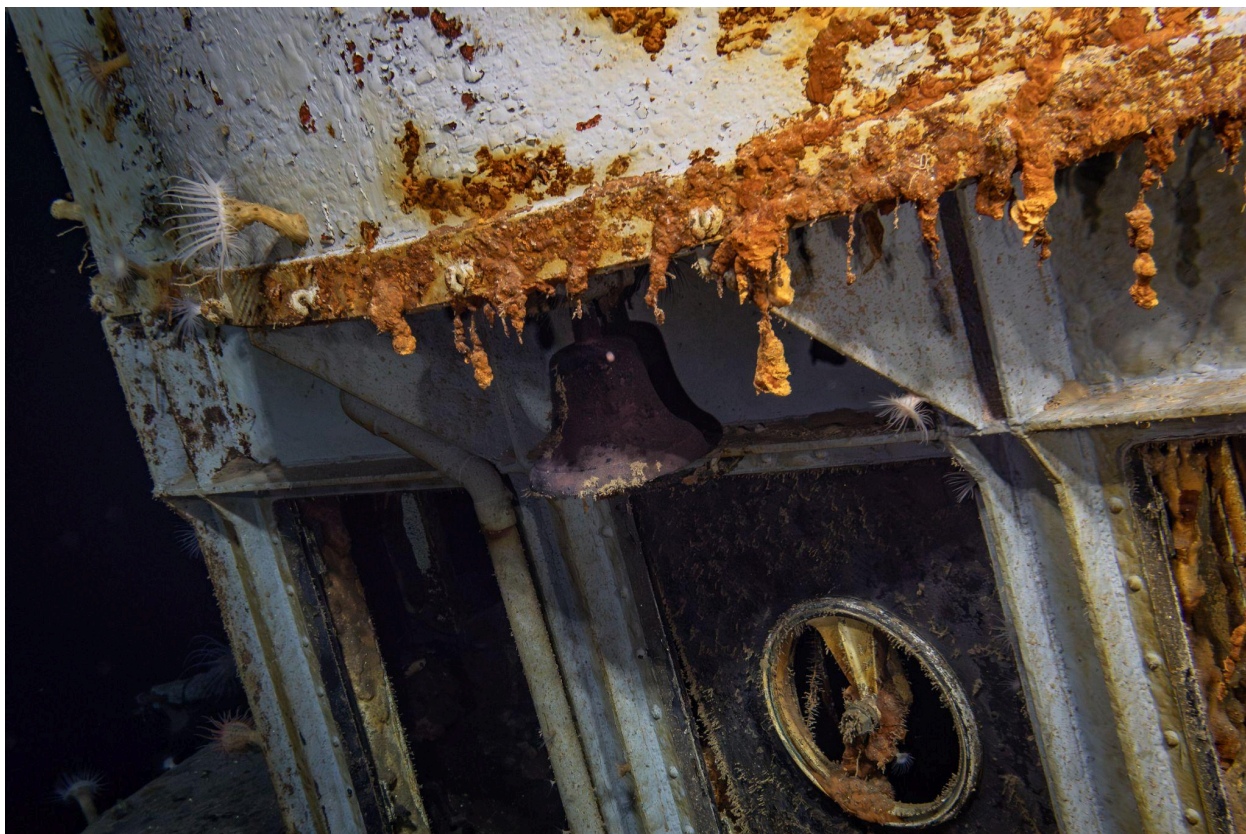
D2 continued to move towards the bow to the forward-most part of the navigation bridge, imaging *Yorktown's* ship bell, which still hung in place forward of the windows. From this forwardmost point, the ROV began its transit again aft, passing the heavily deteriorated stacks, capturing imagery of the ship's horn as well as the top of the stacks and interior damage to the funnel tubes and exterior stack steel. Damage and warping can be seen most on the aft end of the stacks, with the steel structure around the #3 stack completely ripped away and exposing the stack tube. This area also revealed a gun director pedestal with cables emerging, but the director itself was missing.

*Yorktown's* bell can be seen hanging on the forward edge of the ship's bridge.

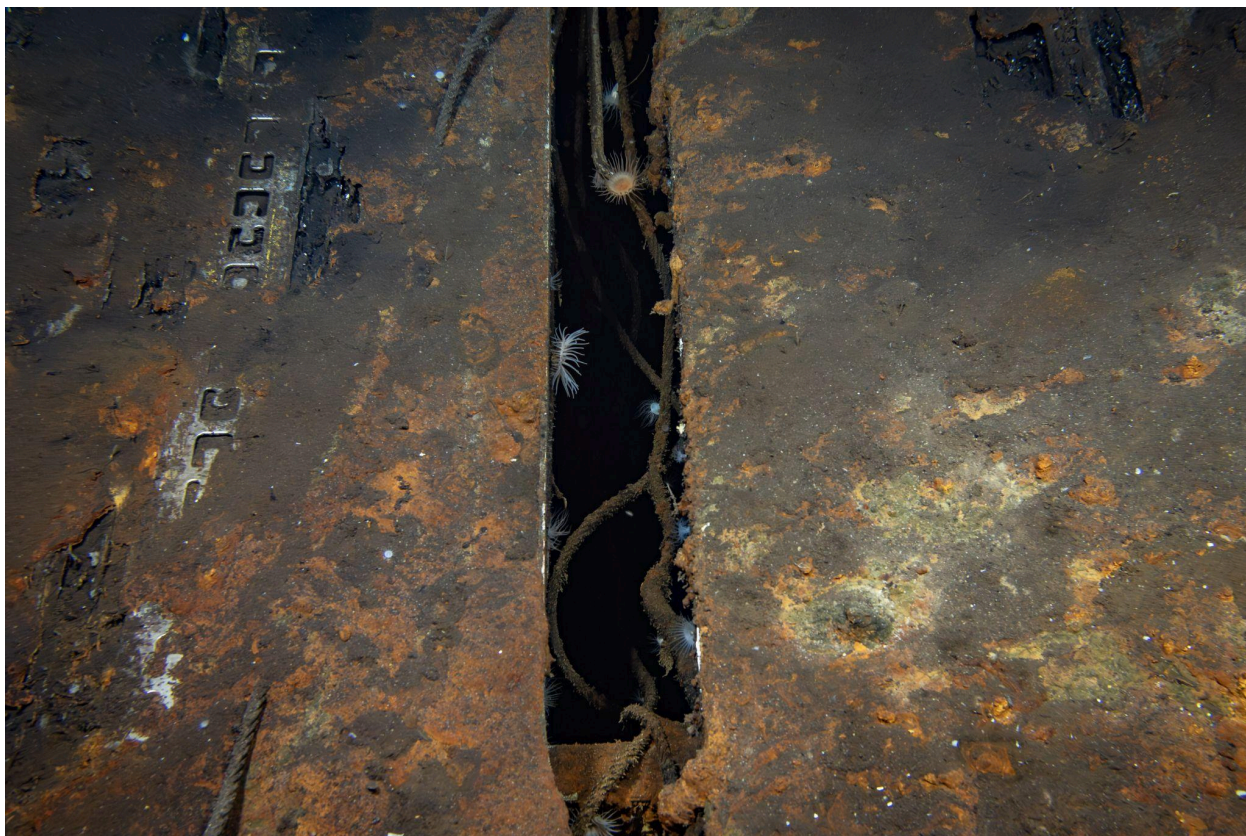
Following the examination of the aft area of the island, D2 turned and traveled aft, imaging a large gap in the flight deck expansion joints, likely around 20cm in width, with the internal structure of the hull visible. Turning, the aft crane was imaged, as well as a quad 1.1" gun, near where a bomb impact on the flight deck injured numerous sailors during the battle.

An expansion joint can be seen in the flight deck of *Yorktown*.

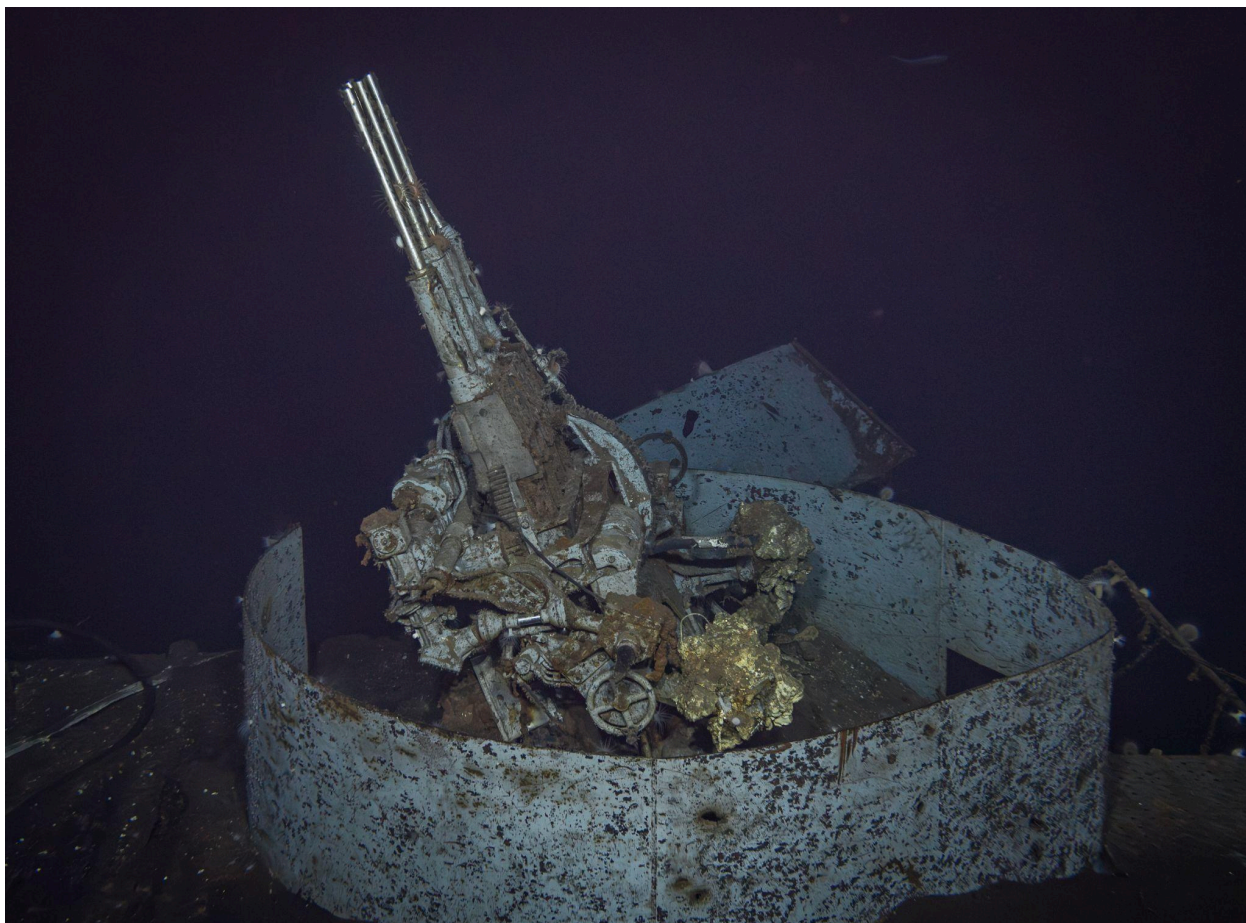
A quad 1.1-inch anti-aircraft gun is seen still pointing skyward, just aft of *Yorktown's* island. This gun was the site of a near-bomb hit, resulting in casualties during the Battle of Midway. The torn away gun tub shield on the far side of the image is likely due to the starboard torpedo strikes from the Japanese sub *I-168*.

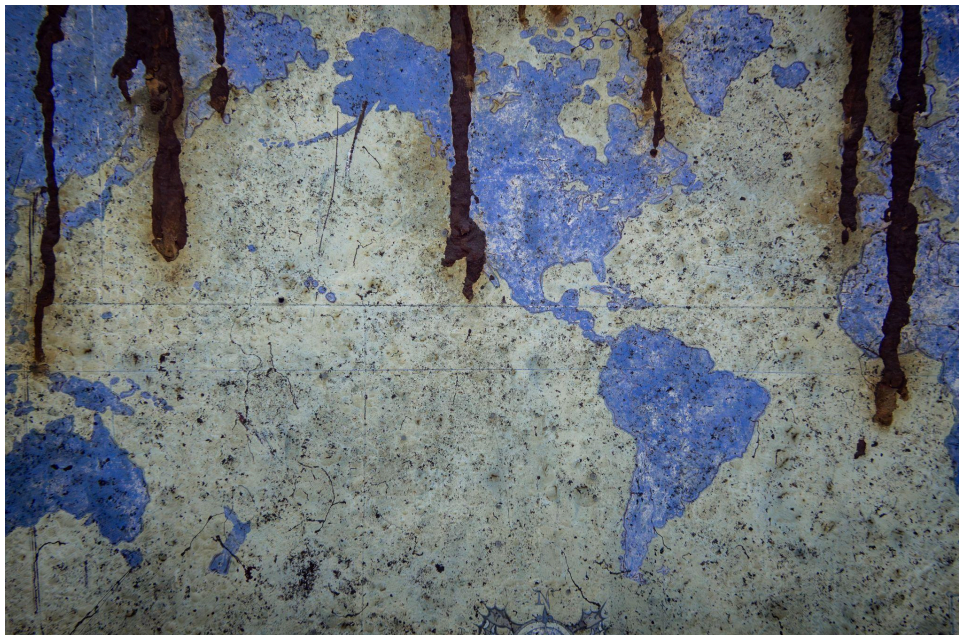
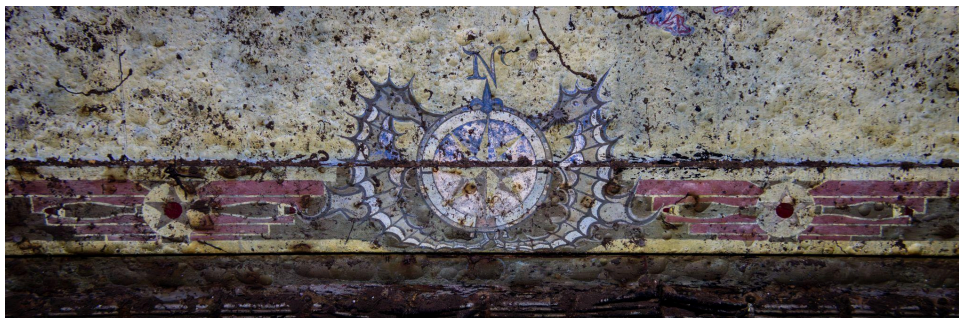
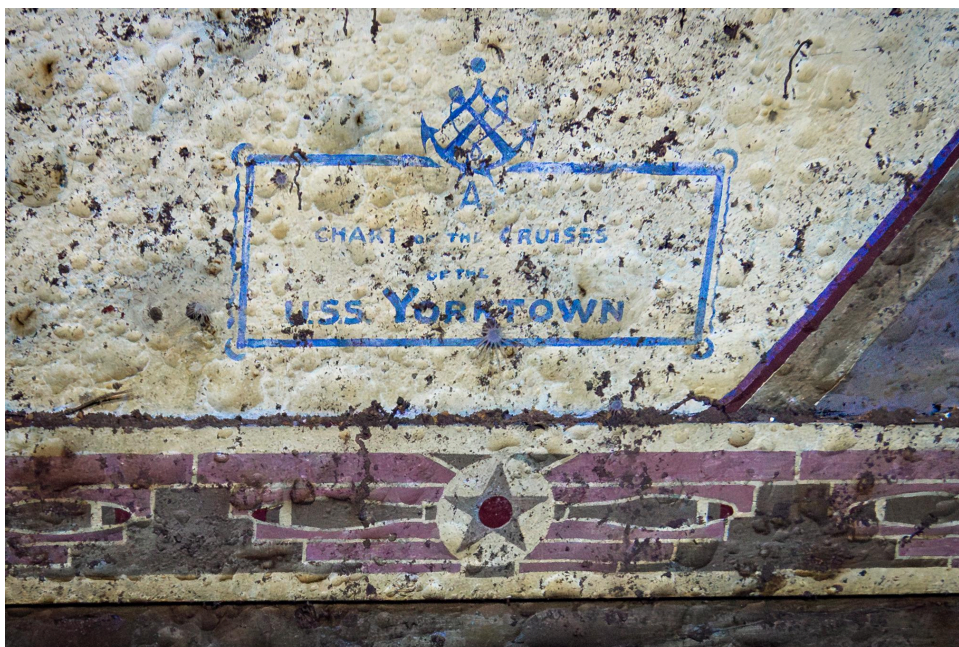
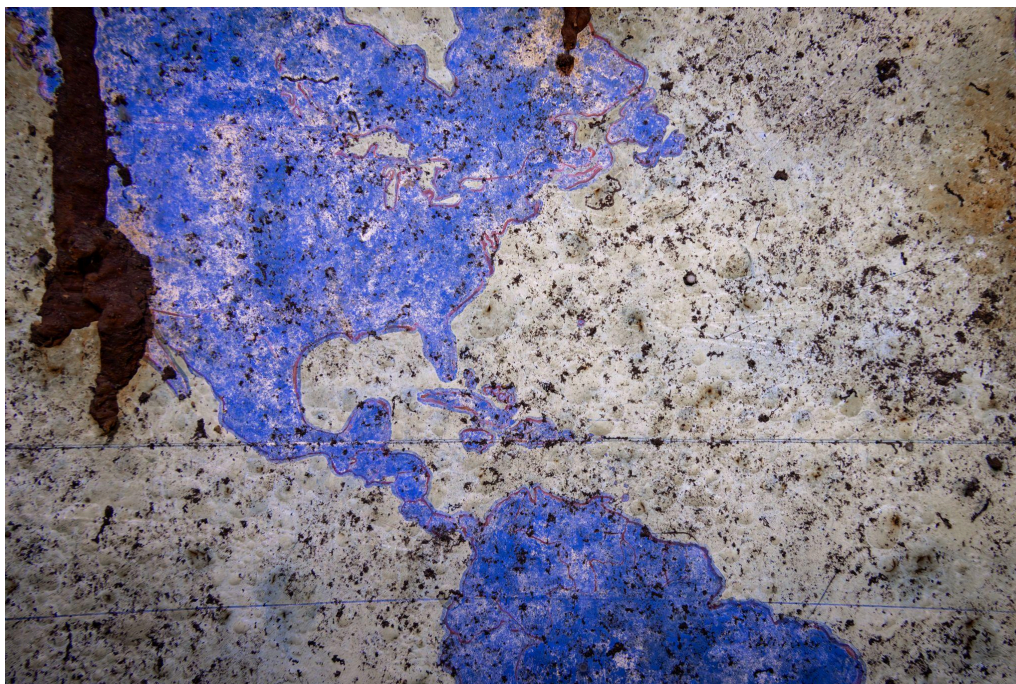
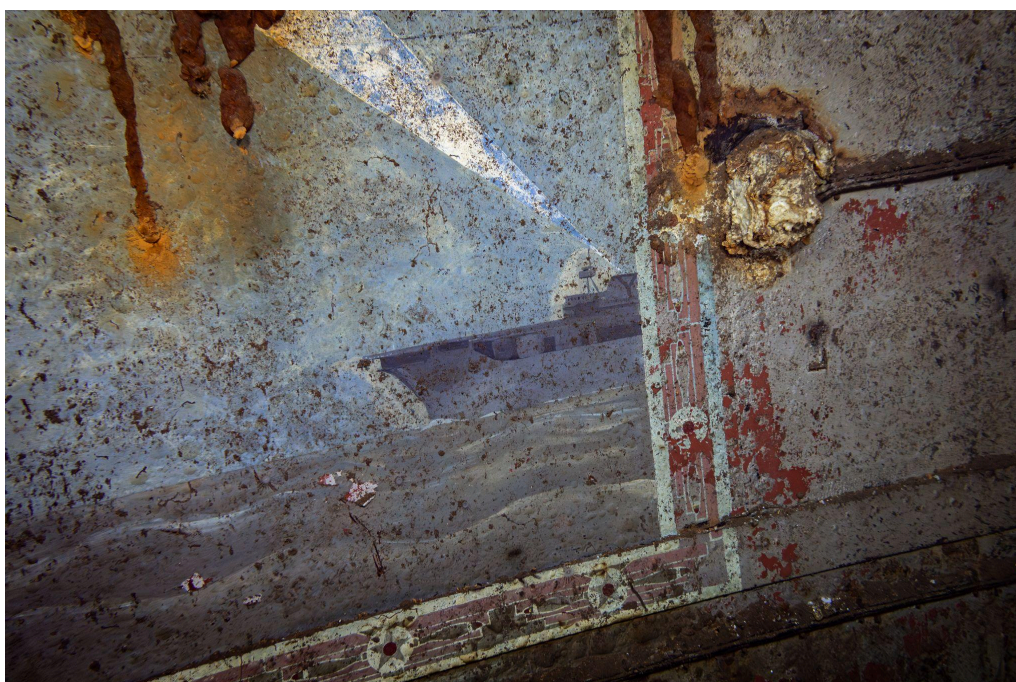
Looking back at the mural, rusticles descend from the top down sections of the mural. In the lower right corner of the map, a legend titled 'A Chart of the Cruises of the USS *Yorktown*' can be seen. Zooming into the map, 'negative' lines can be seen where paint used to exist, likely reflecting transit lines of USS *Yorktown* in her voyages across the Atlantic and Caribbean. Faint traces of paint on the lines remain in areas closer to the Chesapeake Bay and farther north on the map. Other lines carry over towards Europe and the United Kingdom.

Images of the mural found on *Yorktown* in the midships #2 elevator on the interior starboard bulkhead of the ship.

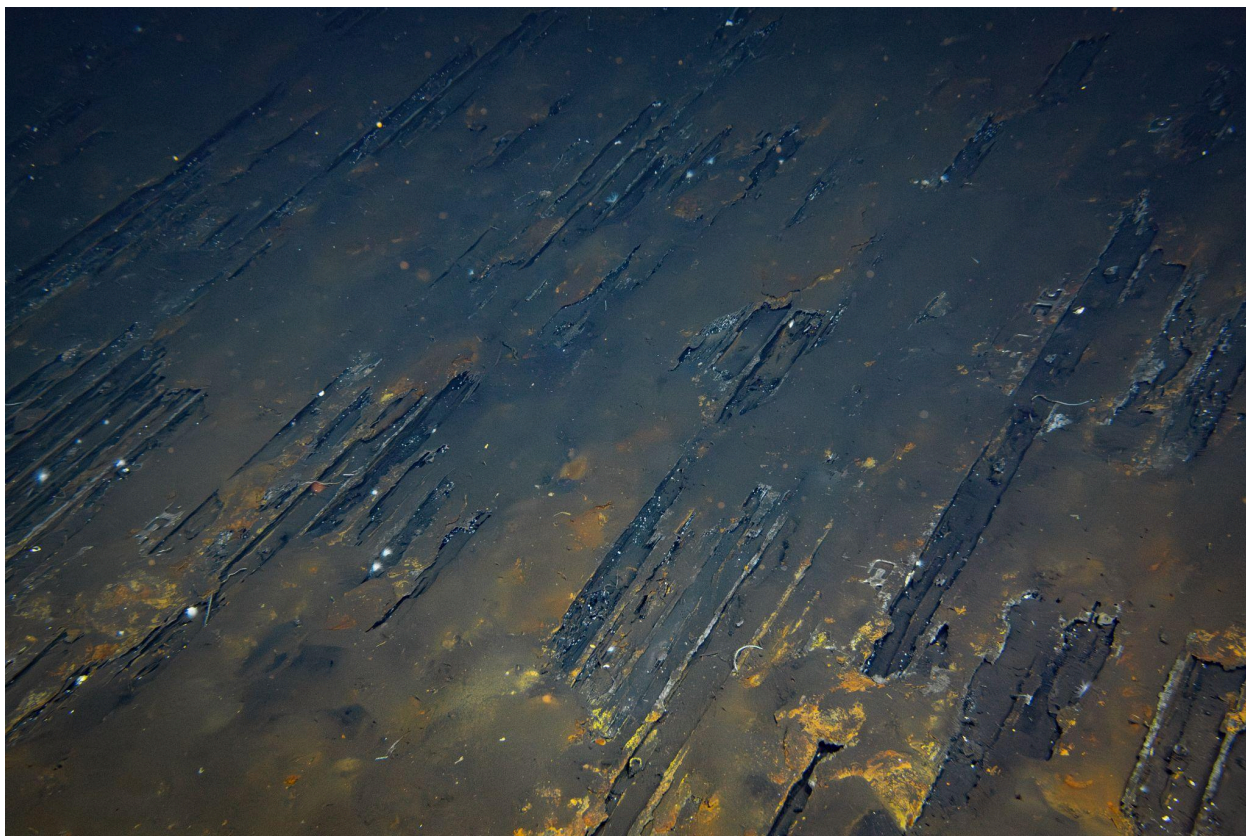
Upon closer inspection of the flight deck, the Douglas fir wooden surface seemed to be mostly intact, covered with a layer of marine snow and sediments.

Condition of the wooden flight deck on board *Yorktown*.

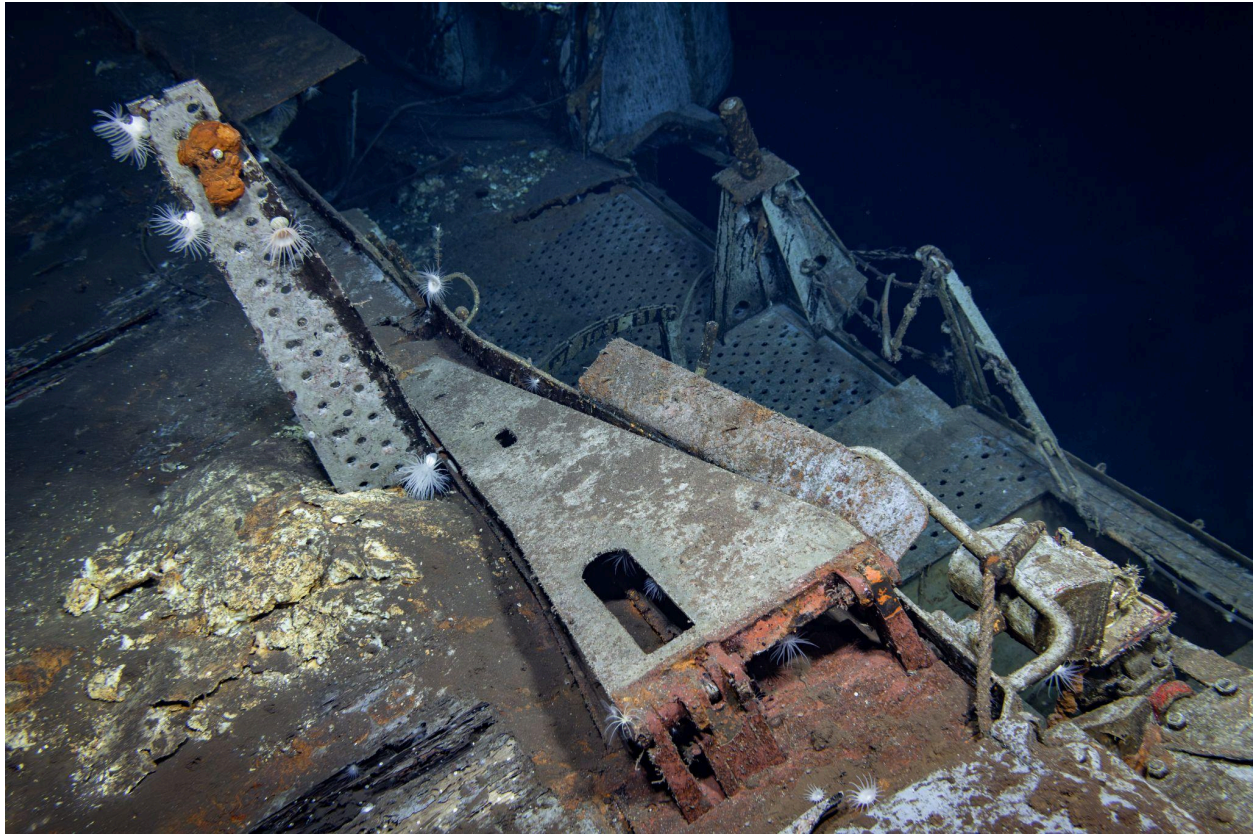
The ROV, after completing the rotational view of the hangar deck, exits the elevator facing forward, with the starboard tilt of Yorktown apparent from a level ROV compared to a listing flight deck. From here, the ROV proceeds aft across the flight deck towards Yorktown's port quarter, with remains of the wooden flight deck, white biological mats covering the remains of wires from the arresting gear, and the remains of the arresting gear stanchions all visible.

A view of the arresting wire stanchions on the flight deck.

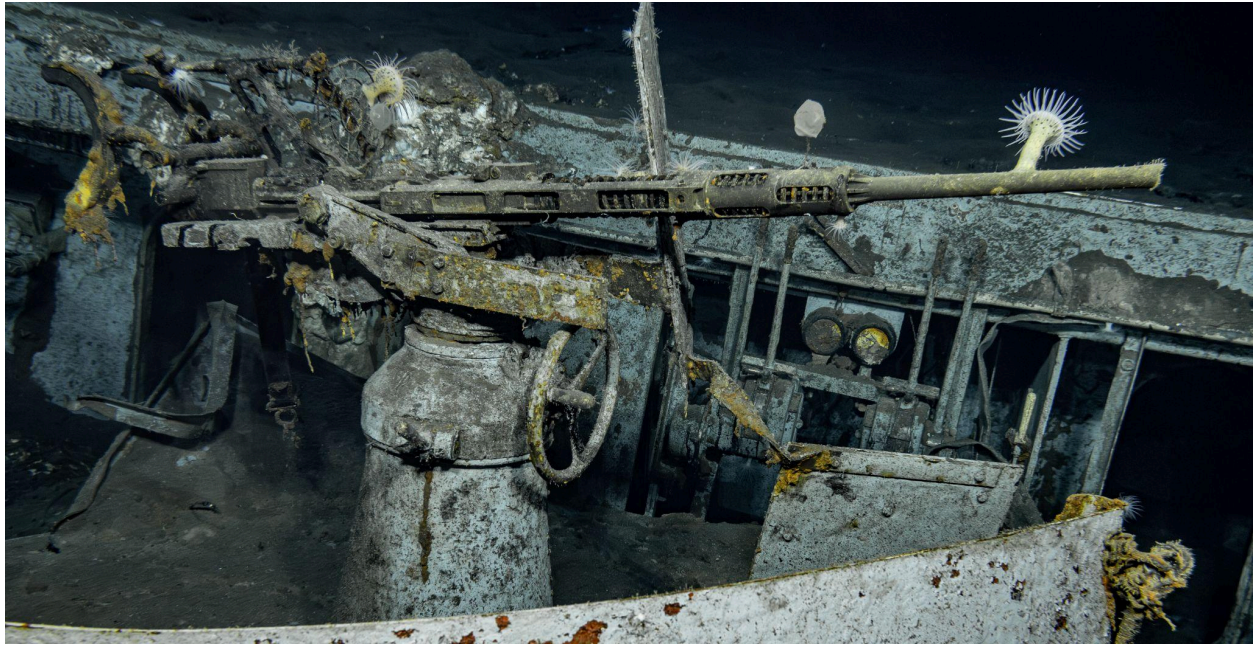
A 20mm Oerlikon mounted on the port aft gun gallery.

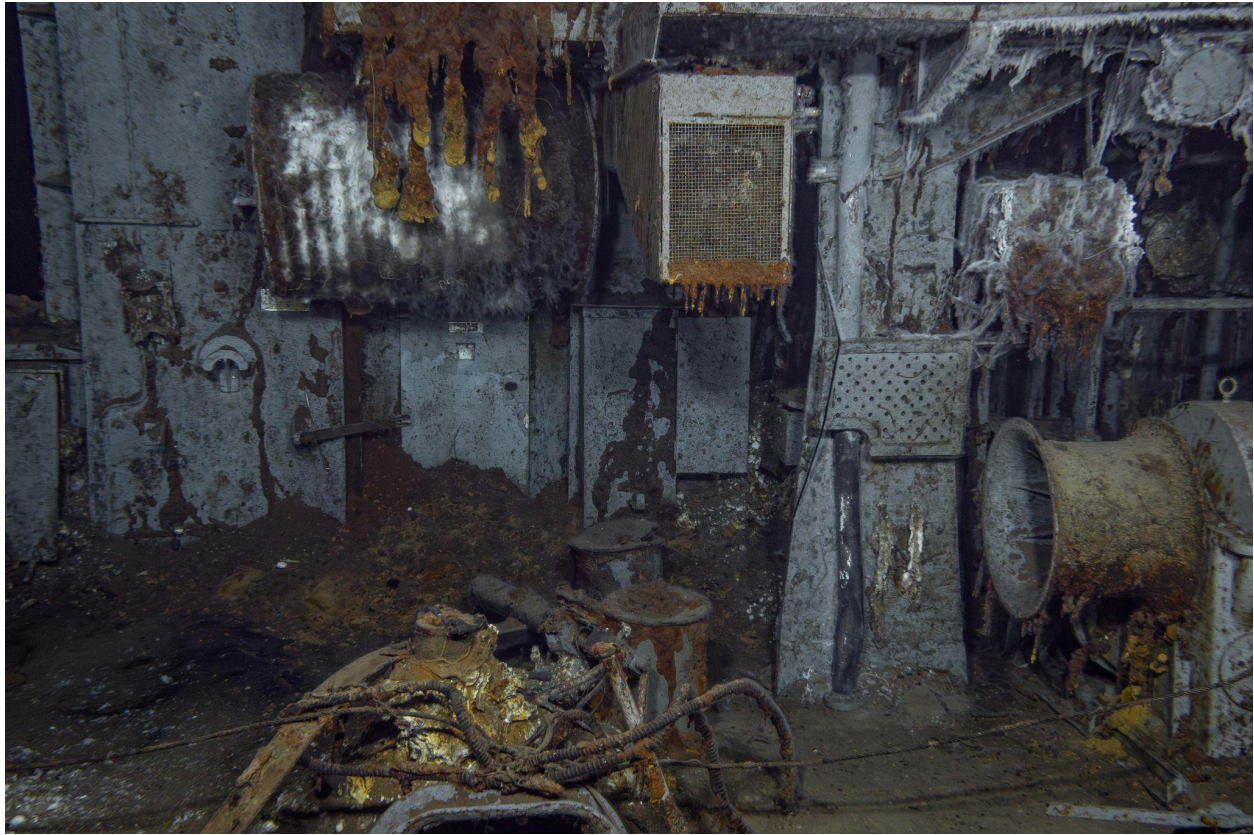
Following further inspection of the gun galleries, D2 drops back to the hangar deck, inspecting the port aft boat davit, located at approximately frame 153, and images Hangar Space 1-153-2. A rolled firehose attached to the bulkhead appears to be covered in some type of bacterial mat. Adjacent to this, a placard describing the use and operation of foam fire extinguishers and equipment was inspected in detail.

A view of machinery on the lower port aft quarter, showing a firefighting hose roll covered in an unidentified bacterial mat.

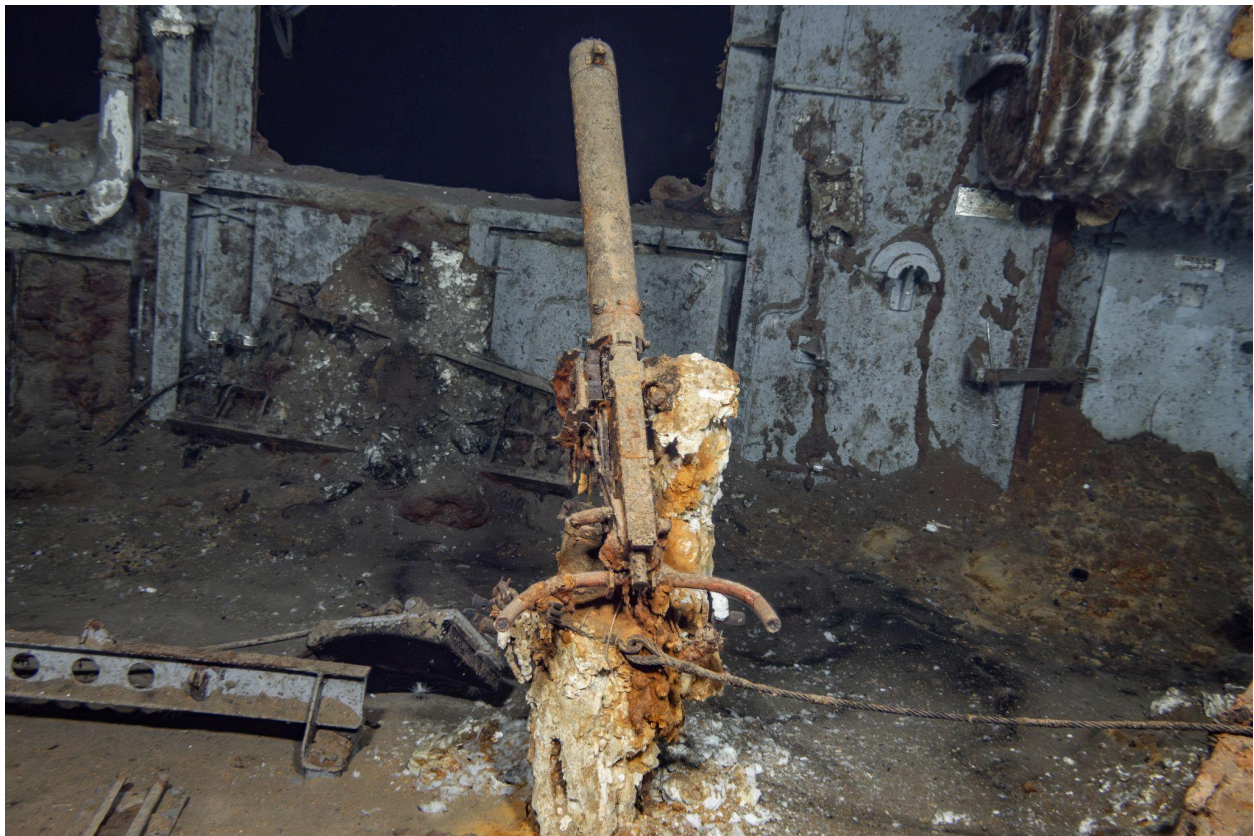
<p>In this same area, a still-mounted .50 caliber machine gun is observed. This is likely the same location where a sailor, presumed dead or missed during the initial evacuation of the ship, crawled from sick bay and fired the weapon, alerting nearby ships to send a boat over and rescue them.</p> <p>Moving further aft, a flight deck expansion joint is seen from below. D2 settles into the hangar deck opening between frames 158 and 172, with multiple overhead lights from the hangar deck visible on the deck where they have fallen due to the sinking event or degradation over time on the seafloor.</p> <p>Far back, near the starboard side of the hangar deck, the faint outline of a car and its chrome hubcaps and trim became visible from the port garage opening on the hangar deck. Based on its shape and outline, it is suspected of being a 1940s Ford Super Deluxe 'Woodie'. Upon exiting the hangar space, a quick look at the 5" guns was taken, where the forward edge of the guntub shields had been removed for both aft port guns, likely in preparation for dumping overboard during salvage to correct the starboard list, similar to the forward port guns, which were jettisoned.</p> <p>D2 begins ascent to the surface.</p>

This particular .50-caliber machine gun was used by Seaman Second Class Norman Pichette and Seaman George Weise to signal destroyer USS *Hughes* (DD-410) which was picking up *Yorktown* survivors. Pichette and Weise had been left in the sick bay due to the severity of their wounds when the abandon ship call was made. Weise survived the war, but Pichette was soon after buried at sea near *Yorktown*. For more information: <https://www.usni.org/magazines/proceedings/2014/july/lest-we-forget-weise-and-pichette>.

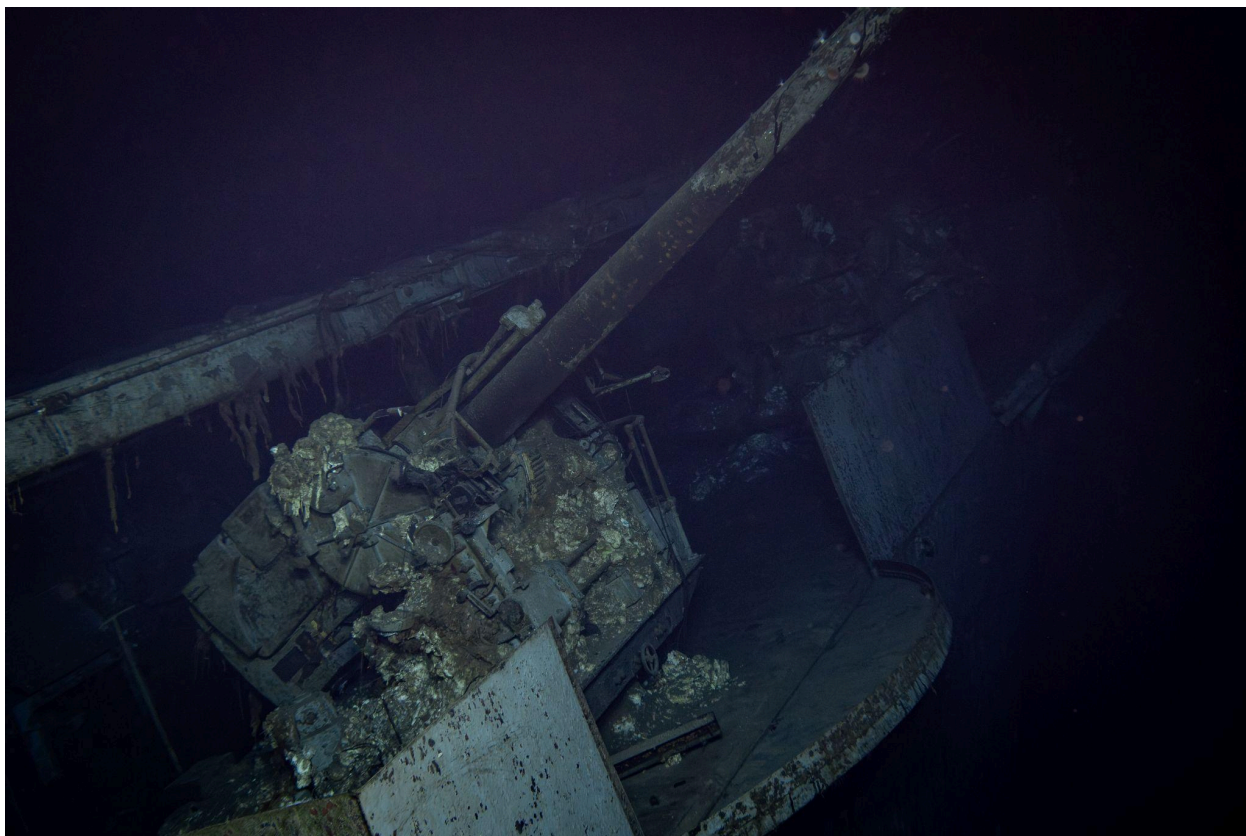
A 5-inch gun in the port aft gun gallery. The guntub shield has been removed, likely in preparation for jettisoning the gun during salvage efforts to correct *Yorktown's* list to starboard before being torpedoed by I-168.
