ROV Dive Summary

EX2503, Dive 07, April 20, 2025

Site Name	USS Yorktown Dive #2
General Area Descriptor	Papahānaumokuākea
Science Team Leads	Sara Kahanamoku-Meyer (UH Mānoa/HI Sea Grant) and Brian Kennedy (ODL/BU)
Expedition Coordinator	Sam Cuellar (NOAA Ocean Exploration)
ROV Dive Supervisor	Chris Ritter (GFOE)
Mapping Lead	Neah Baechler (NOAA Ocean Exploration/UCAR)
Sample Data Manager	Anna Lienesch and Jordan Schweizer (NCEI)

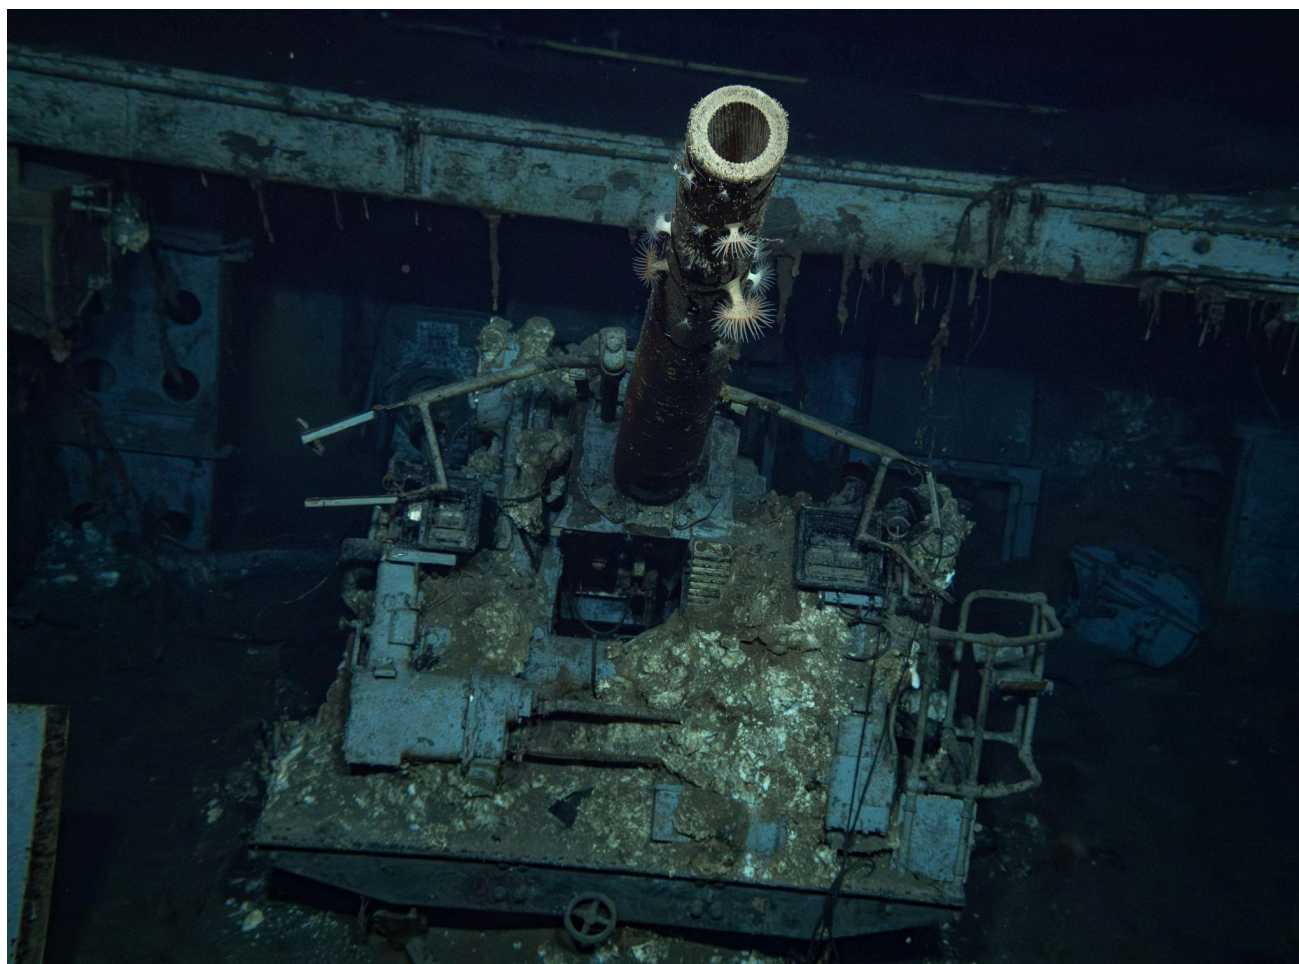
D2 progressed aft investigating hatches, and the catwalk just below the flight deck that allowed fore and aft movement by sailors without interfering with aircraft operations. Panning aft of the catwalk, *Yorktown's* big 5" anti-aircraft guns were observed around Frame 174 with their shields unbolted, probably in jettisoning efforts by damage control crews. The hinged semi-circle platforms are in the upright/deployed position. Hormathiidae anemones growing on the rifled barrel. *D2* got some insightful views of the 5" turret mechanics, trainer seat, electronics, and a data plate. On the after-most 5" gun around frame 183 is a hauser line and a rubber firehose once stowed inboard of the gun gallery and now tangled around the base of the barrel, possibly connected to the jettisoning efforts, or entangled during the wrecking event.

A 5-inch gun seen on the port aft gun gallery, with the gun tub shield removed.

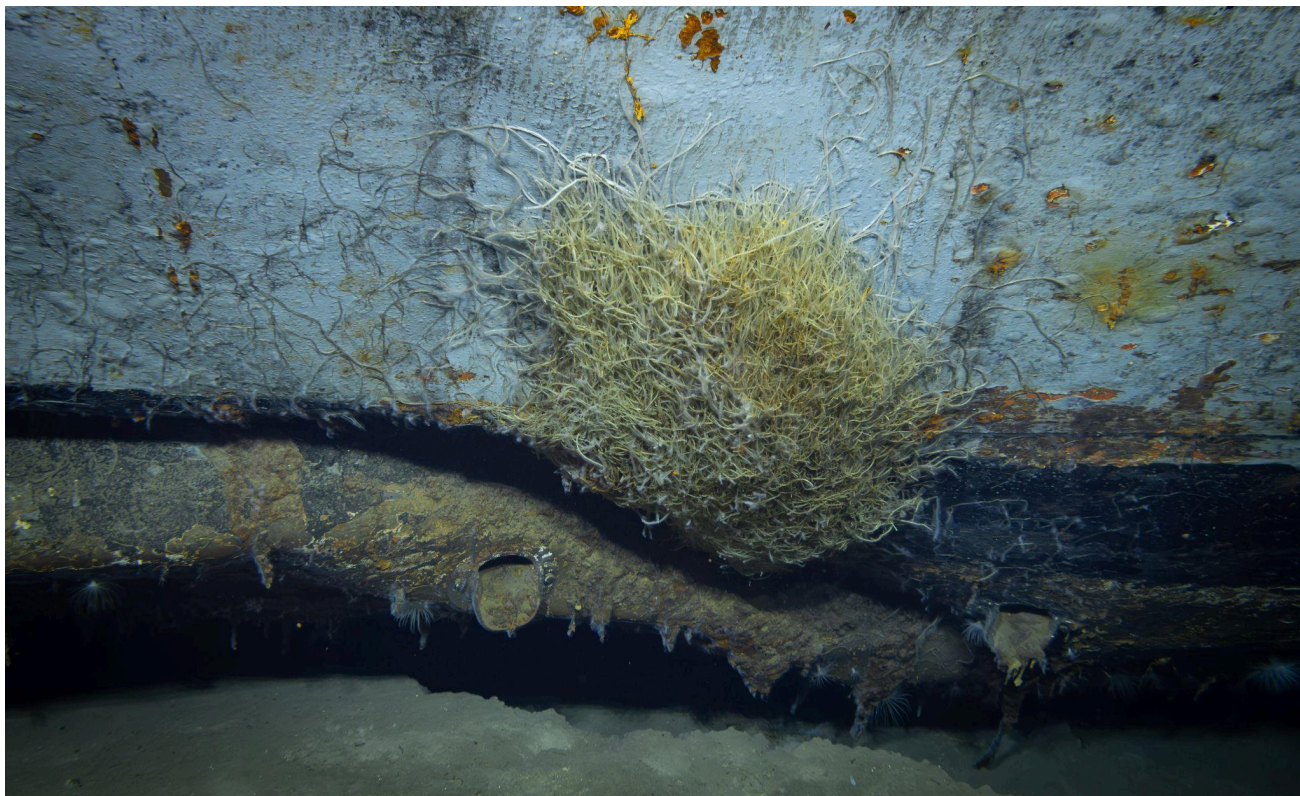
Unidentified tubeworms are seen surrounding an outflow pipe on *Yorktown's* hull on the port side near the stern.

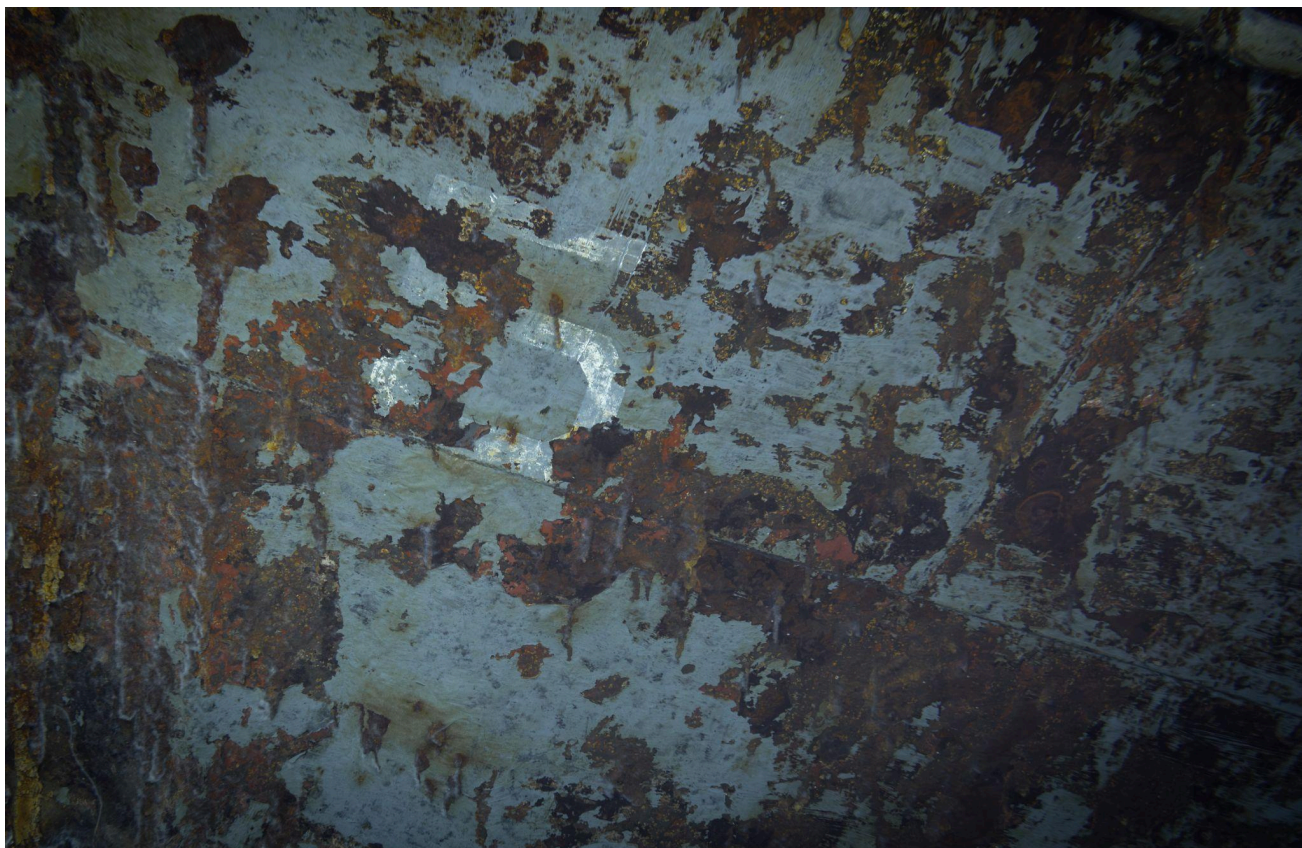
The white '5' is seen on *Yorktown's* stern.

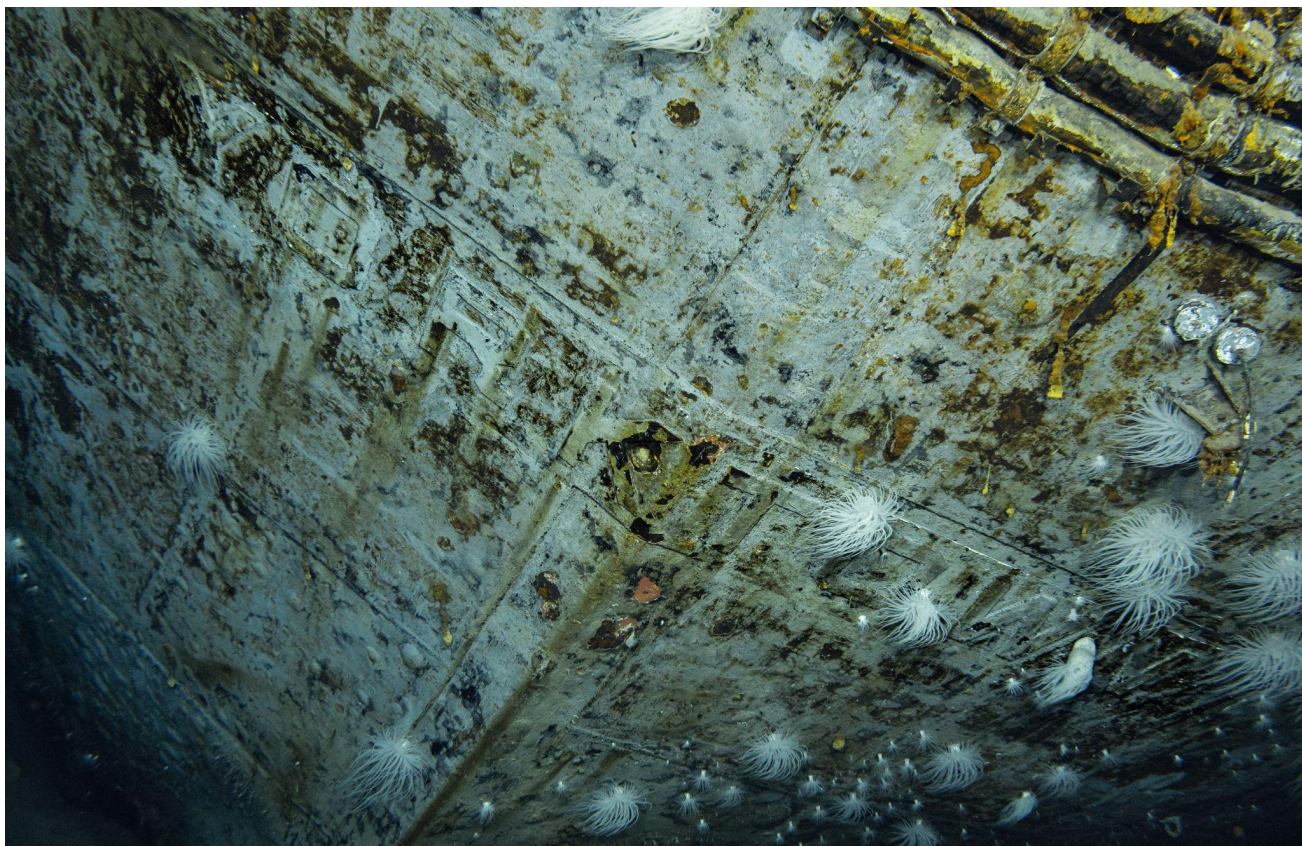
'Yorktown' as seen on the ship's stern in raised letters.

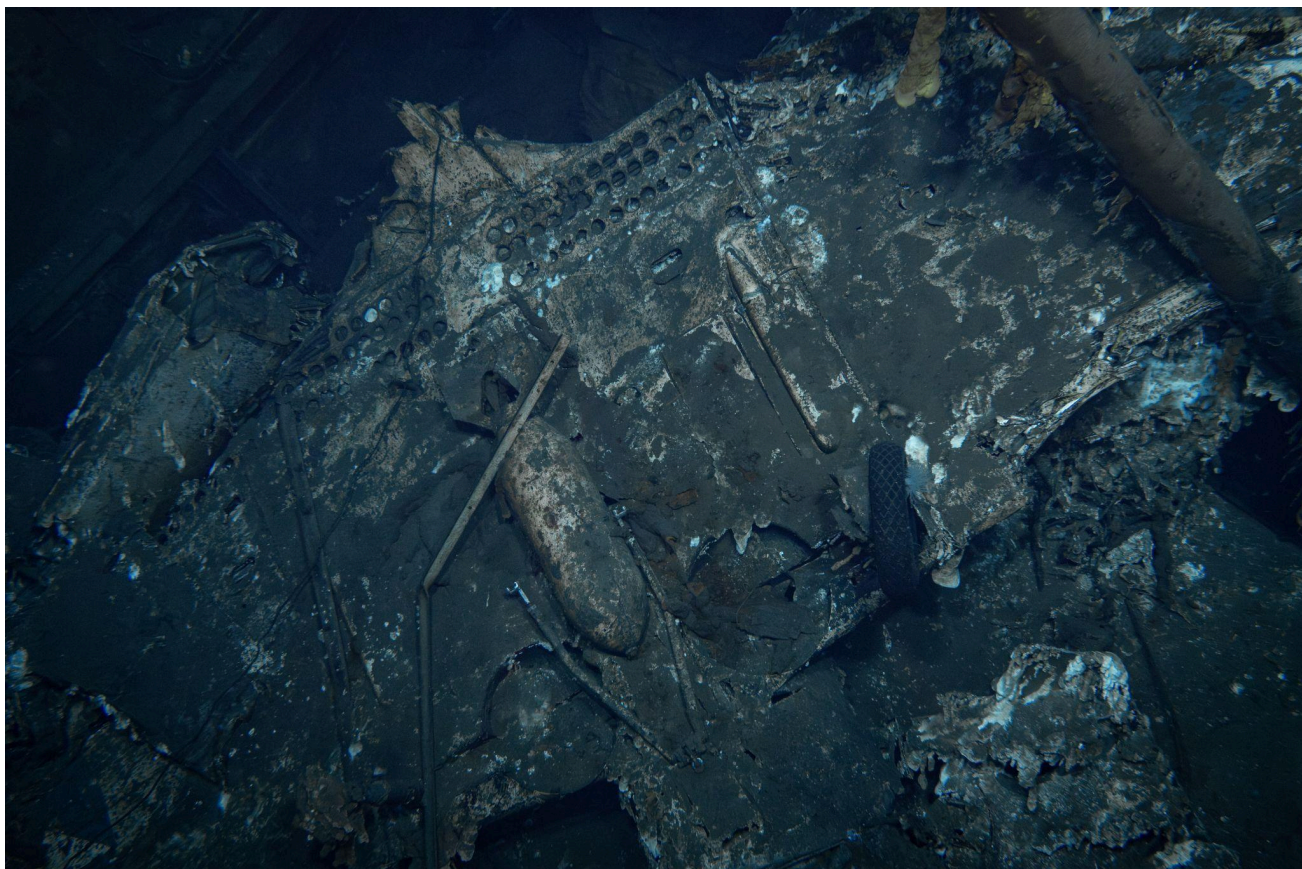
One of these other planes had a 500lb bomb still secured to its release cradle. Aviation-grade oxygen storage cylinders were seen lining the walls and fallen over on the inboard side of the shaft. *D2* continued hovering over the aircraft and zooming on items in view, including a hatch with plate "Squadroom Storerooms 02-186". *D2* ascended out of Shaft #3 and continued forward on the starboard side, imaging the starboard aft 5" guns, and completed another dive objective: confirming the wing seen on the 2023 NA154 dive. Based on the oil cooler opening and shell ejection chutes, it's likely this once belonged to an F4F Wildcat fighter.

An overturned Douglas SBD-3 'Dauntless' dive bomber in the aft #3 elevator on *Yorktown*, still armed with a 500-lb bomb. This aircraft is one of several seen in a pile in the #3 elevator.

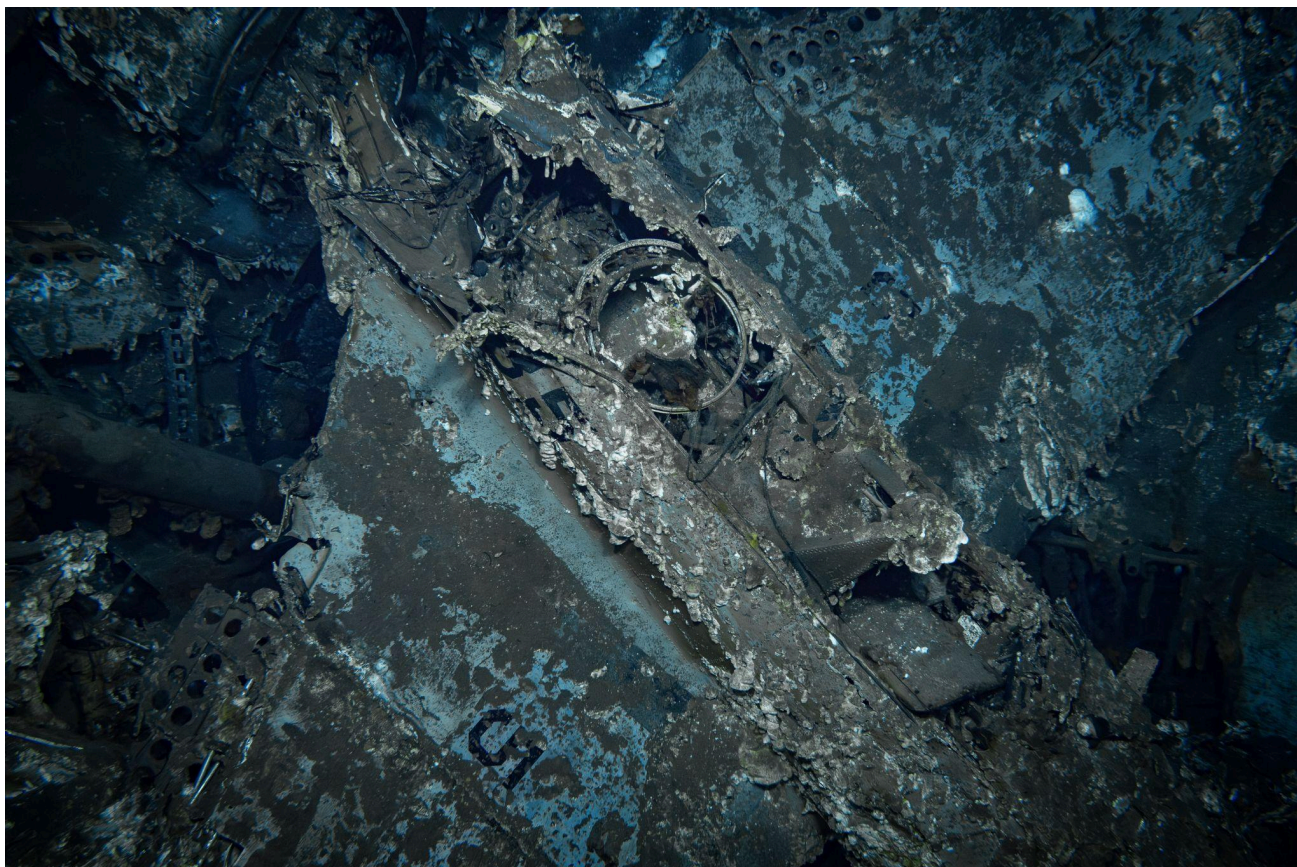
Douglas SBD-3 Dauntless '6-B-5' (BuNo 4581) of Bombing Squadron Six from *USS Enterprise* is seen here in elevator #3. Identified by its markings and historical records, 6-B-5 was among the first to attack the Japanese carrier *Kaga*. *Yorktown's* after-action report states that two battle-damaged *Enterprise* SBDs were recovered and struck below during the battle, but it did not give fuselage codes. However, the pilot of 6-B-5's name appears among the muster list of survivors rescued from *Yorktown* after it was abandoned.

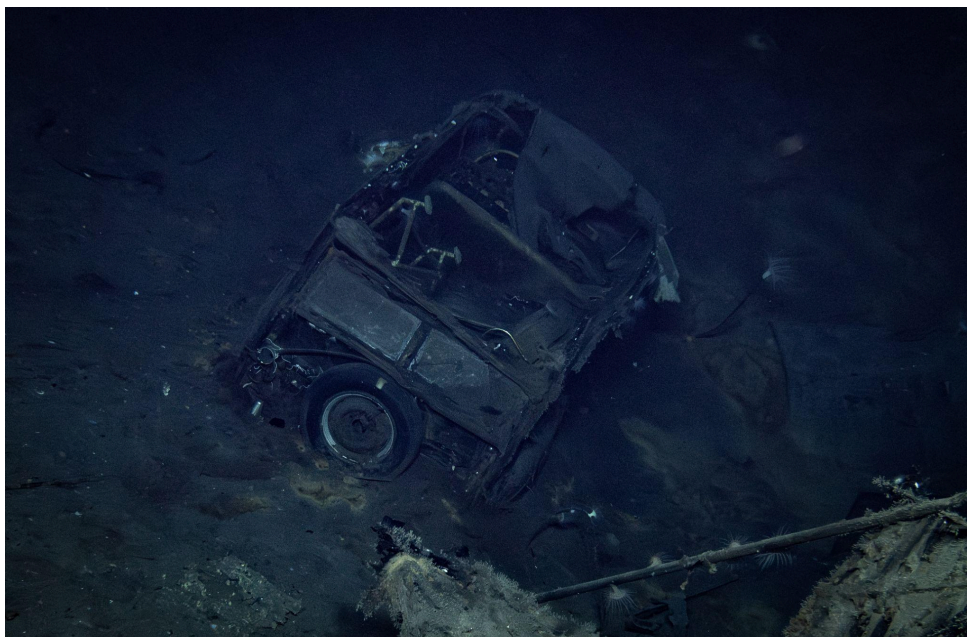
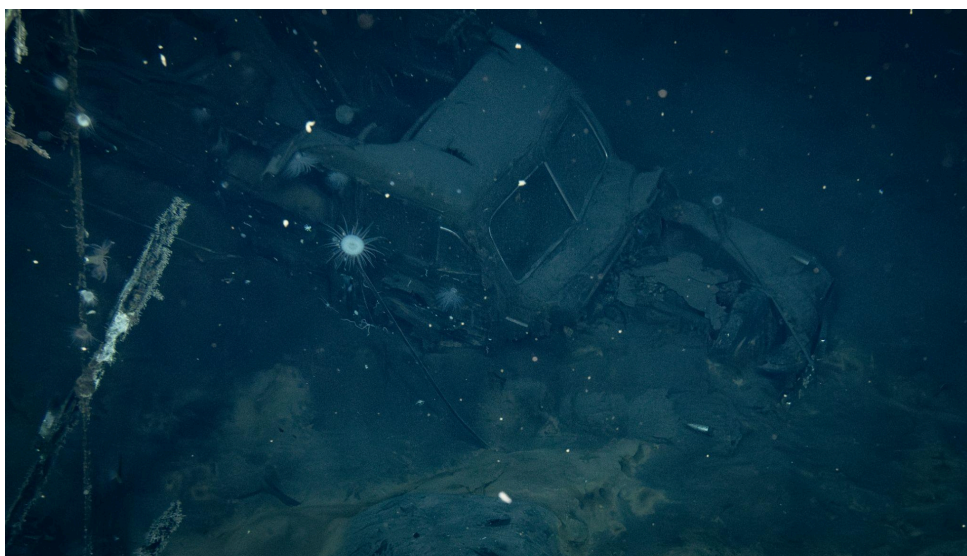
From this starboard vantage point into the hangar deck and just past the F4F wing, *D2* collected more video on the car, which was observed to have a cloth roof, intact bumper, and chrome trim pieces, and a license plate reading "SHIP SERVICE" on its top line and potentially "CV-5" or "NAVY" on the bottom line. Its hood was blown off, but the split windshield was intact. The team later identified this as a 1941 Ford Super Deluxe Woody. A roll-up door that once shielded this opening into the hangar deck from weather lays in the sediment. Just forward of the F4F wing and the Woody is the starboard side small boat davit at the mudline. This davit would deploy and retrieve the 50'0" Officers' Boat and the 50'0" Motor Launch, both missing. Just above, the 50-caliber and 20mm Oerlikon gun galleries were observed as *D2* continued forward. Rubber on the Oerlikon shoulder pads is still intact. On the same gallery, a fire pump made by "American LaFrance" still has paint, gauges, and rubber hoses.

Views from the aft #3 elevator and starboard hangar door of a suspected 1941 Ford Super Deluxe 'Woody' discovered on the hangar deck of *Yorktown*.

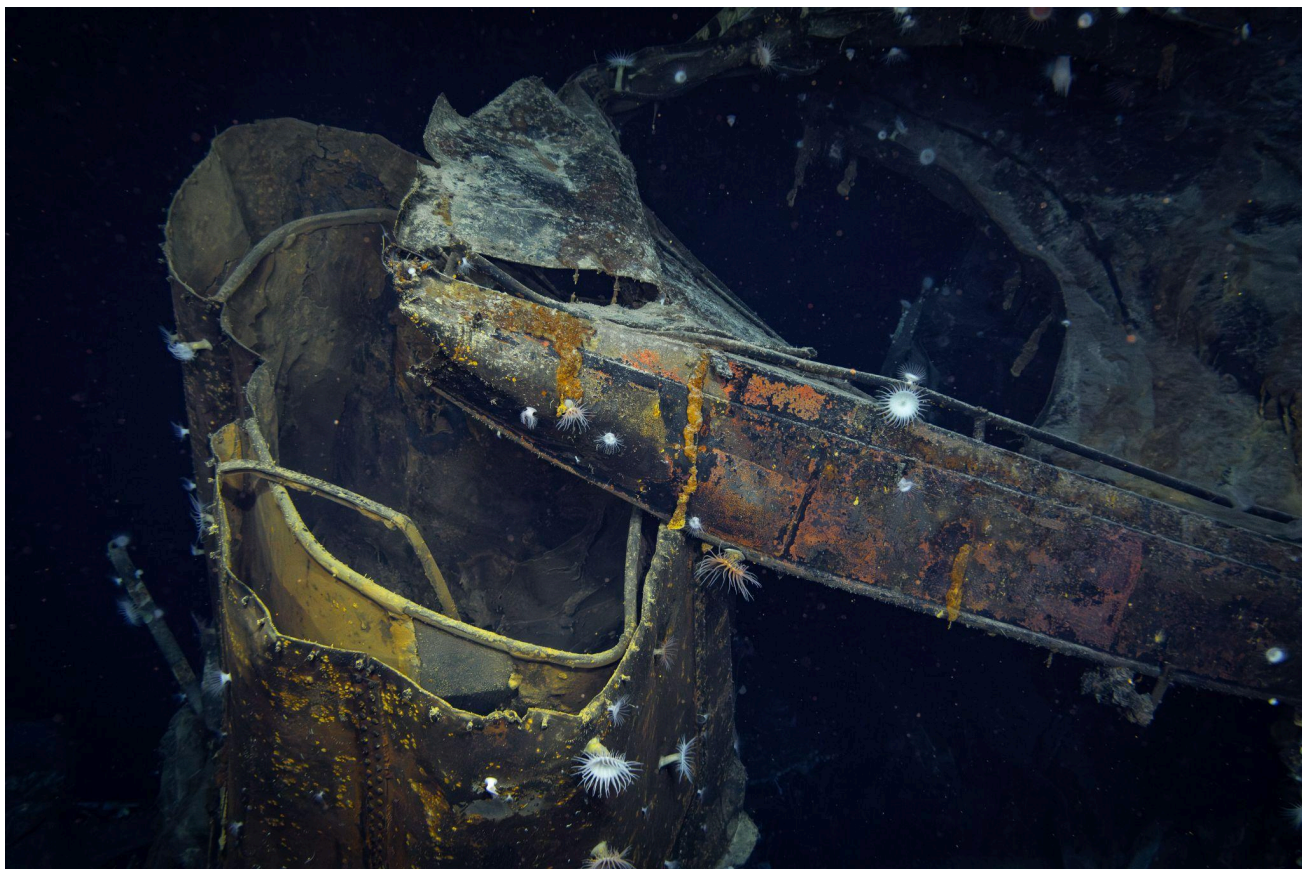
Remains of Stack #4 on the aft end of *Yorktown's* island.
