*NOAA SHIP OKEANOS EXPLORER R-337*  
*“America’s Ship for Ocean Exploration”*

## **EX0909 Mapping Field Trials**

**Necker Ridge**

## **CRUISE REPORT**

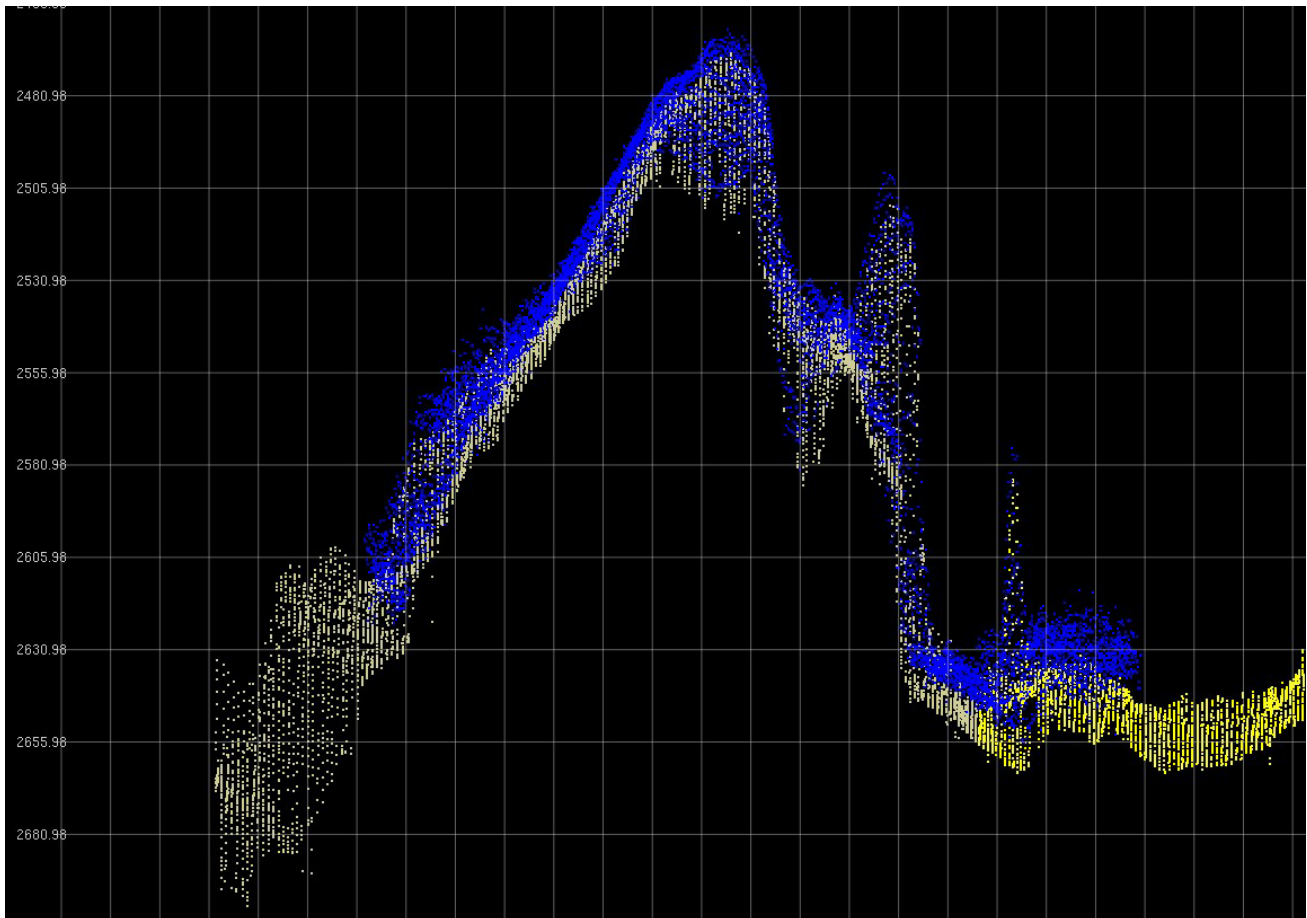
*Figure 3: Screenshot of subset editor in CARIS HIPS showing the difference between the cross line (blue) and the main scheme lines (yellow and white). Image credit: NOAA*

The cross line yielded a favorable comparison between two (Lines 16 & 35) of the five main scheme lines. The other two (Line 23, and Lines 28 & 29) saw differences in spots of up to six meters in 2500m of water.

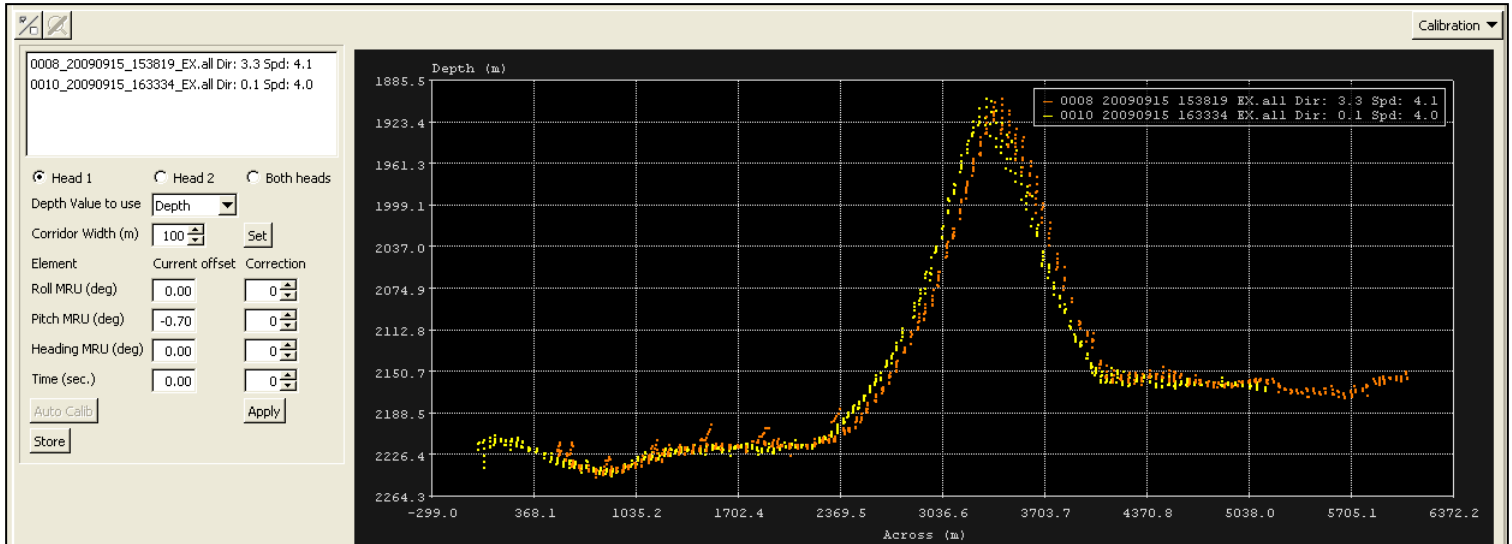
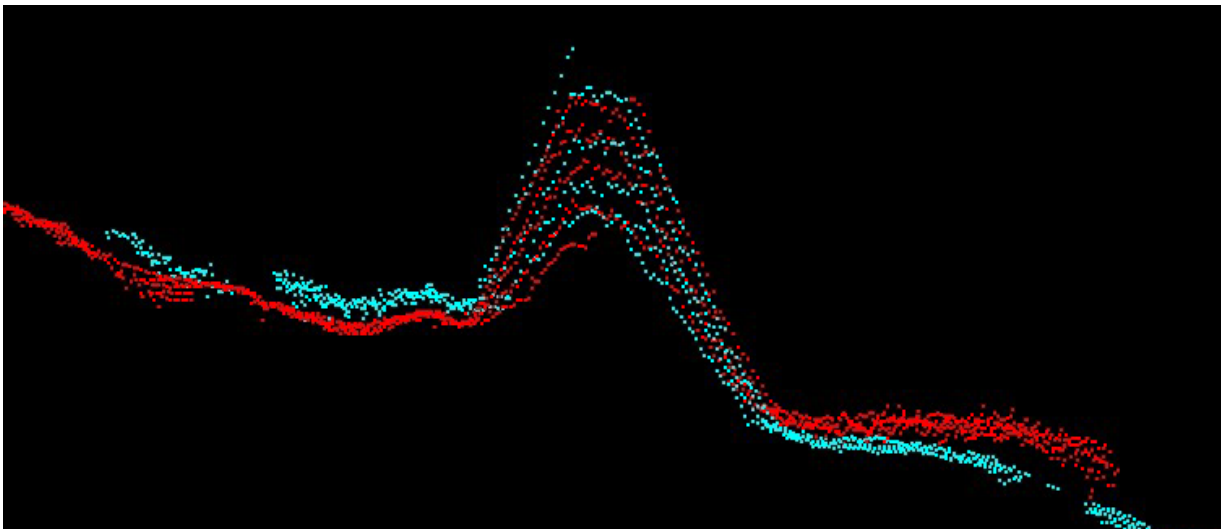
Figures 6 and 7: Top – The calibration screen in SIS showing the offset in the heading lines. Bottom – The heading lines in Caris subset editor after the -1.1 degree offset had been applied in SIS.

0700 ~ finished patch test and began mapping operations along Necker Ridge. Upon initial processing of the patch test data, a -1.1 degree heading offset was observed. PS Mashkoor Malik was notified at UNH, who enlisted the help of Dr. Jim Gardner, who both agreed that this was an unusually large offset. They also both concluded that a second heading test, using the same yaw test lines, should be run with this offset applied, as well as finding another “linear” feature on a flat surface at some point during the cruise for another test. After the heading lines were rerun with the -1.1 offset, the data still required a new offset of 0.7, which showed that applying an offset was not solving this problem. Additionally, when the data was processed in Caris, a large difference of 20-25m was noticed in the outer beams between the two lines. The heading offset was

changed back to zero and the ship resumed mapping along Necker Ridge. After the first lines had been processed along the Ridge, ribbing artifacts were still present in the outer beams. The same amount of error was observed as initially detected from the first lines run along Necker Ridge on August 26<sup>th</sup> of 2-10m. Since the results of the patch test found that no offsets needed to be applied, it seems unlikely that it is a heading or roll artifact. PS Malik will contact Kongsberg rep. Jared Harris for additional insight into this problem and to see whether or not this could be an issue within SIS or the TRU.

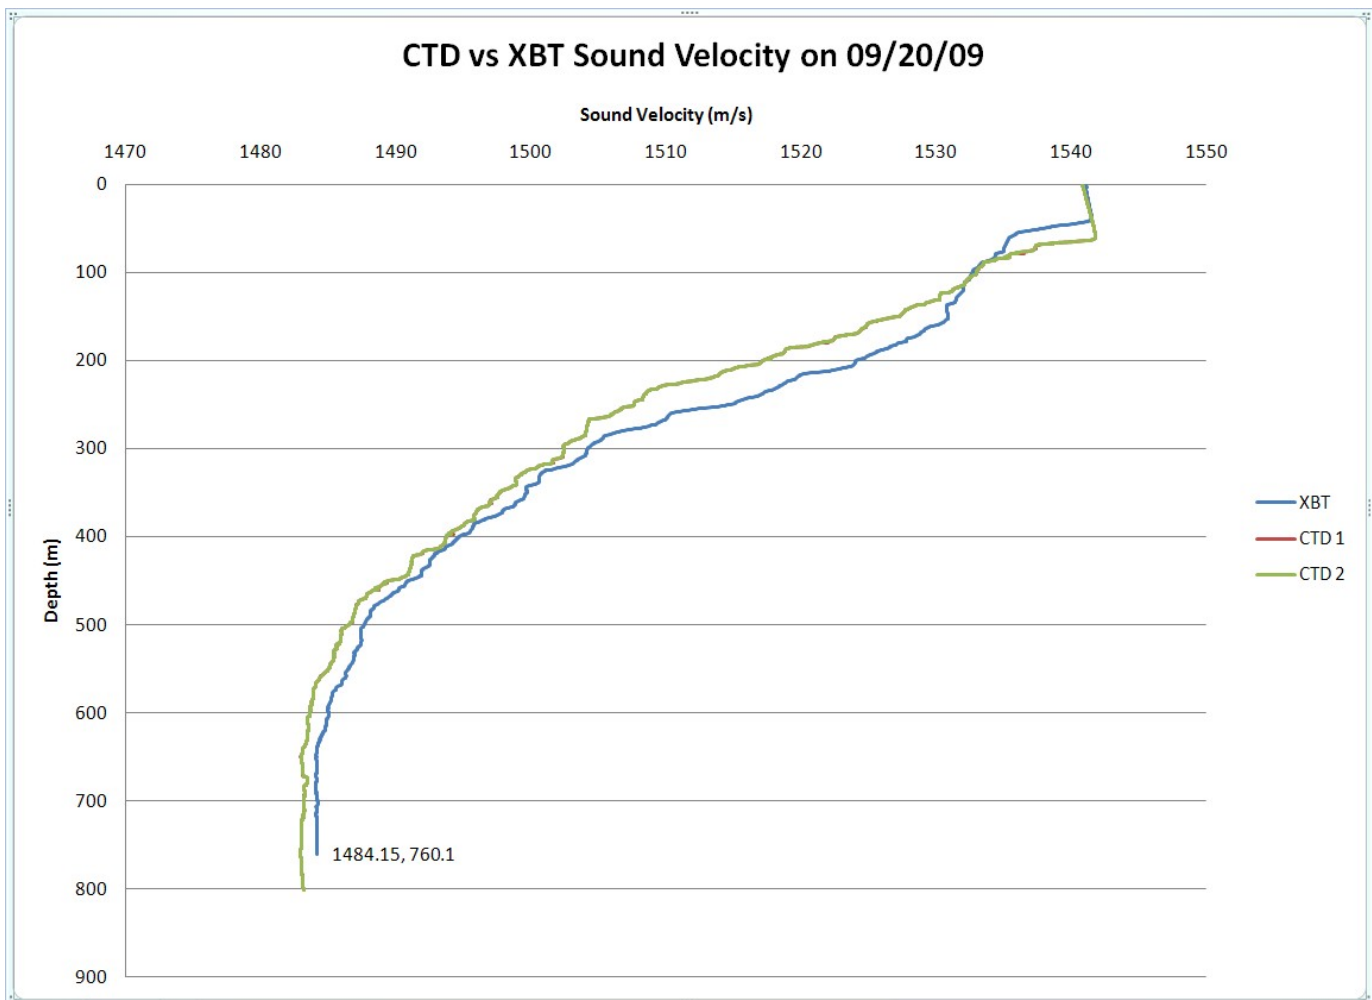
Figure 9: Comparison between XBT & CTD sound velocity measurements.

Continue mapping west of Necker Ridge. 0600 ~ noticed that SCS position did not match position on the bridge because sensor information not updating properly in SCS. ET's looked into it and rebooted the SQL database server and position updated properly in SCS afterwards. 0830-1130 ~ a deep CTD cast was performed to a depth of 4200m and a XBT directly afterwards to compare the profiles. The comparison yielded results

of up to 8 m/s difference, which most likely was the result from the casts not being taken exactly at the same time from the same spot. Another CTD/SVP comparison will be done with tomorrow's cast at noon with the addition of these two components if possible. After the casts were complete, the ship began the cross line that covers four of the six mainscheme lines.
