NOAA SHIP OKEANOS EXPLORER R-337
“America’s Ship for Ocean Exploration”

EX0909 Mapping Field Trials

Necker Ridge

CRUISE REPORT

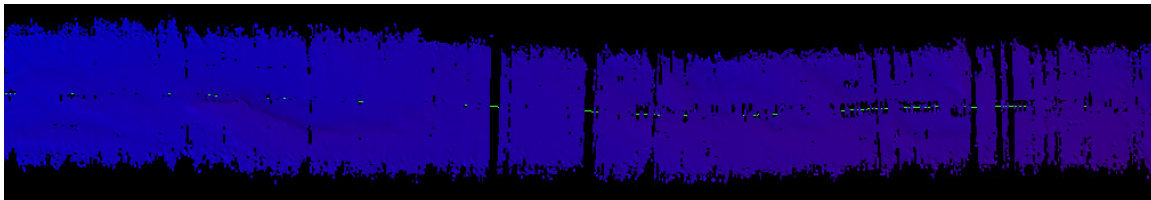
Figure 5a: Screen grabs of the grids (upper panel). The line on the right side of the panel was run by 0.5 deg transmit opening angle. The line on the left side of the panel was run by 1 deg transmit opening angle. The panel on the bottom show a screen capture from the Subset editor showing that line with 0.5 deg transmit opening angle appears to be more noisier. The orange, blue and grey colors show sounding points from line with 0.5 deg transmit opening angle, 1 deg transmit opening angles and the points that were manually rejected in the HIPS subset editor (water depth approximately 4500m).

The data quality was observed to degrade in depths greater than 3500 m where excessive artifacts were observed. Different settings were changed to see if the data quality can be improved including increasing the beam width for transmit beam to 1 deg from 0.5 deg. 1 deg transmit beam with High density equi-distant mode (HIDENEQDIST) mode provided the best quality data in depths greater than 3500 m. In areas over the ridge where the depth was < 3500 m, 0.5 deg transmit beam was utilized to improve the resolution of resulting bathymetric data.

Ship left harbor ~ 0900 for Necker Ridge. The data quality was determined to be deteriorating with increasing depths. A lot of data artifacts were observed. Different settings were tested to determine best possible data quality achievable. It was found that 1 deg transmit beam width provided best possible data in deep water.
