# **CRUISE REPORT**

## **U.S. Law of the Sea Cruise to Map the Eastern Mendocino Ridge, Eastern Pacific Ocean**

**CRUISE EX0903**

UNH-CCOM/JHC Technical Report 09-001

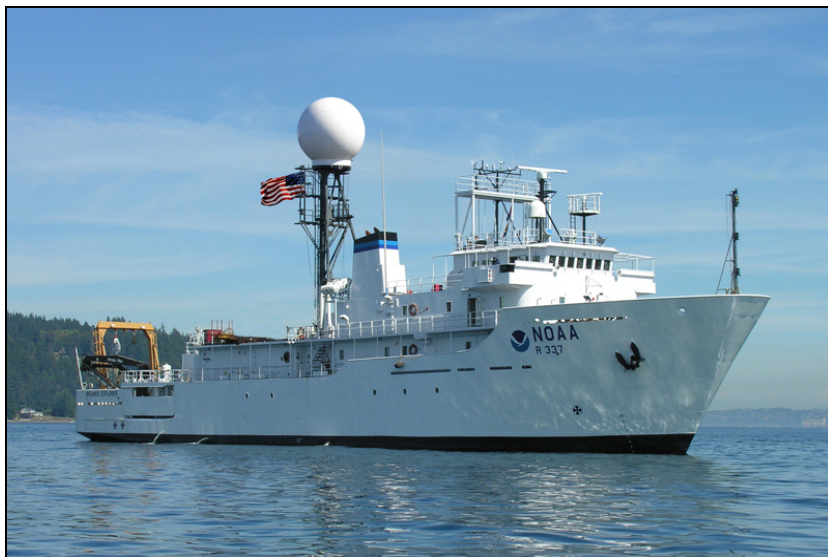
Figure 2. NOAA Ship *Okeanos Explorer* (R337) used to map the eastern Mendocino Ridge.

The NOAA Ocean Exploration Program made available the 224-ft, 2298 metric ton ship *Okeanos Explorer* (Fig. 2) with a hull-mounted Kongsberg Simrad EM302 MBES and a Knudsen 3260 3.5-kHz CHIRP sub-bottom profiler. Early testing of the Knudsen 3260 sub-bottom profiler demonstrated severe cross talk between the sub-bottom profiler and the MBES because of the lack of synchronization between the two systems. Consequently, the Knudsen profiler was not used during the mapping phase of the cruise. The schedule for the cruise called for 5 days of testing and 16 days of mapping with the EM302 MBES.
